EMSR872 - AOI02
Tropical Cyclone Sinlaku in Micronesia
UDOT

Situation as of 27/04/2026 00:44 UTC
Grading MONIT01 - Overview map 01

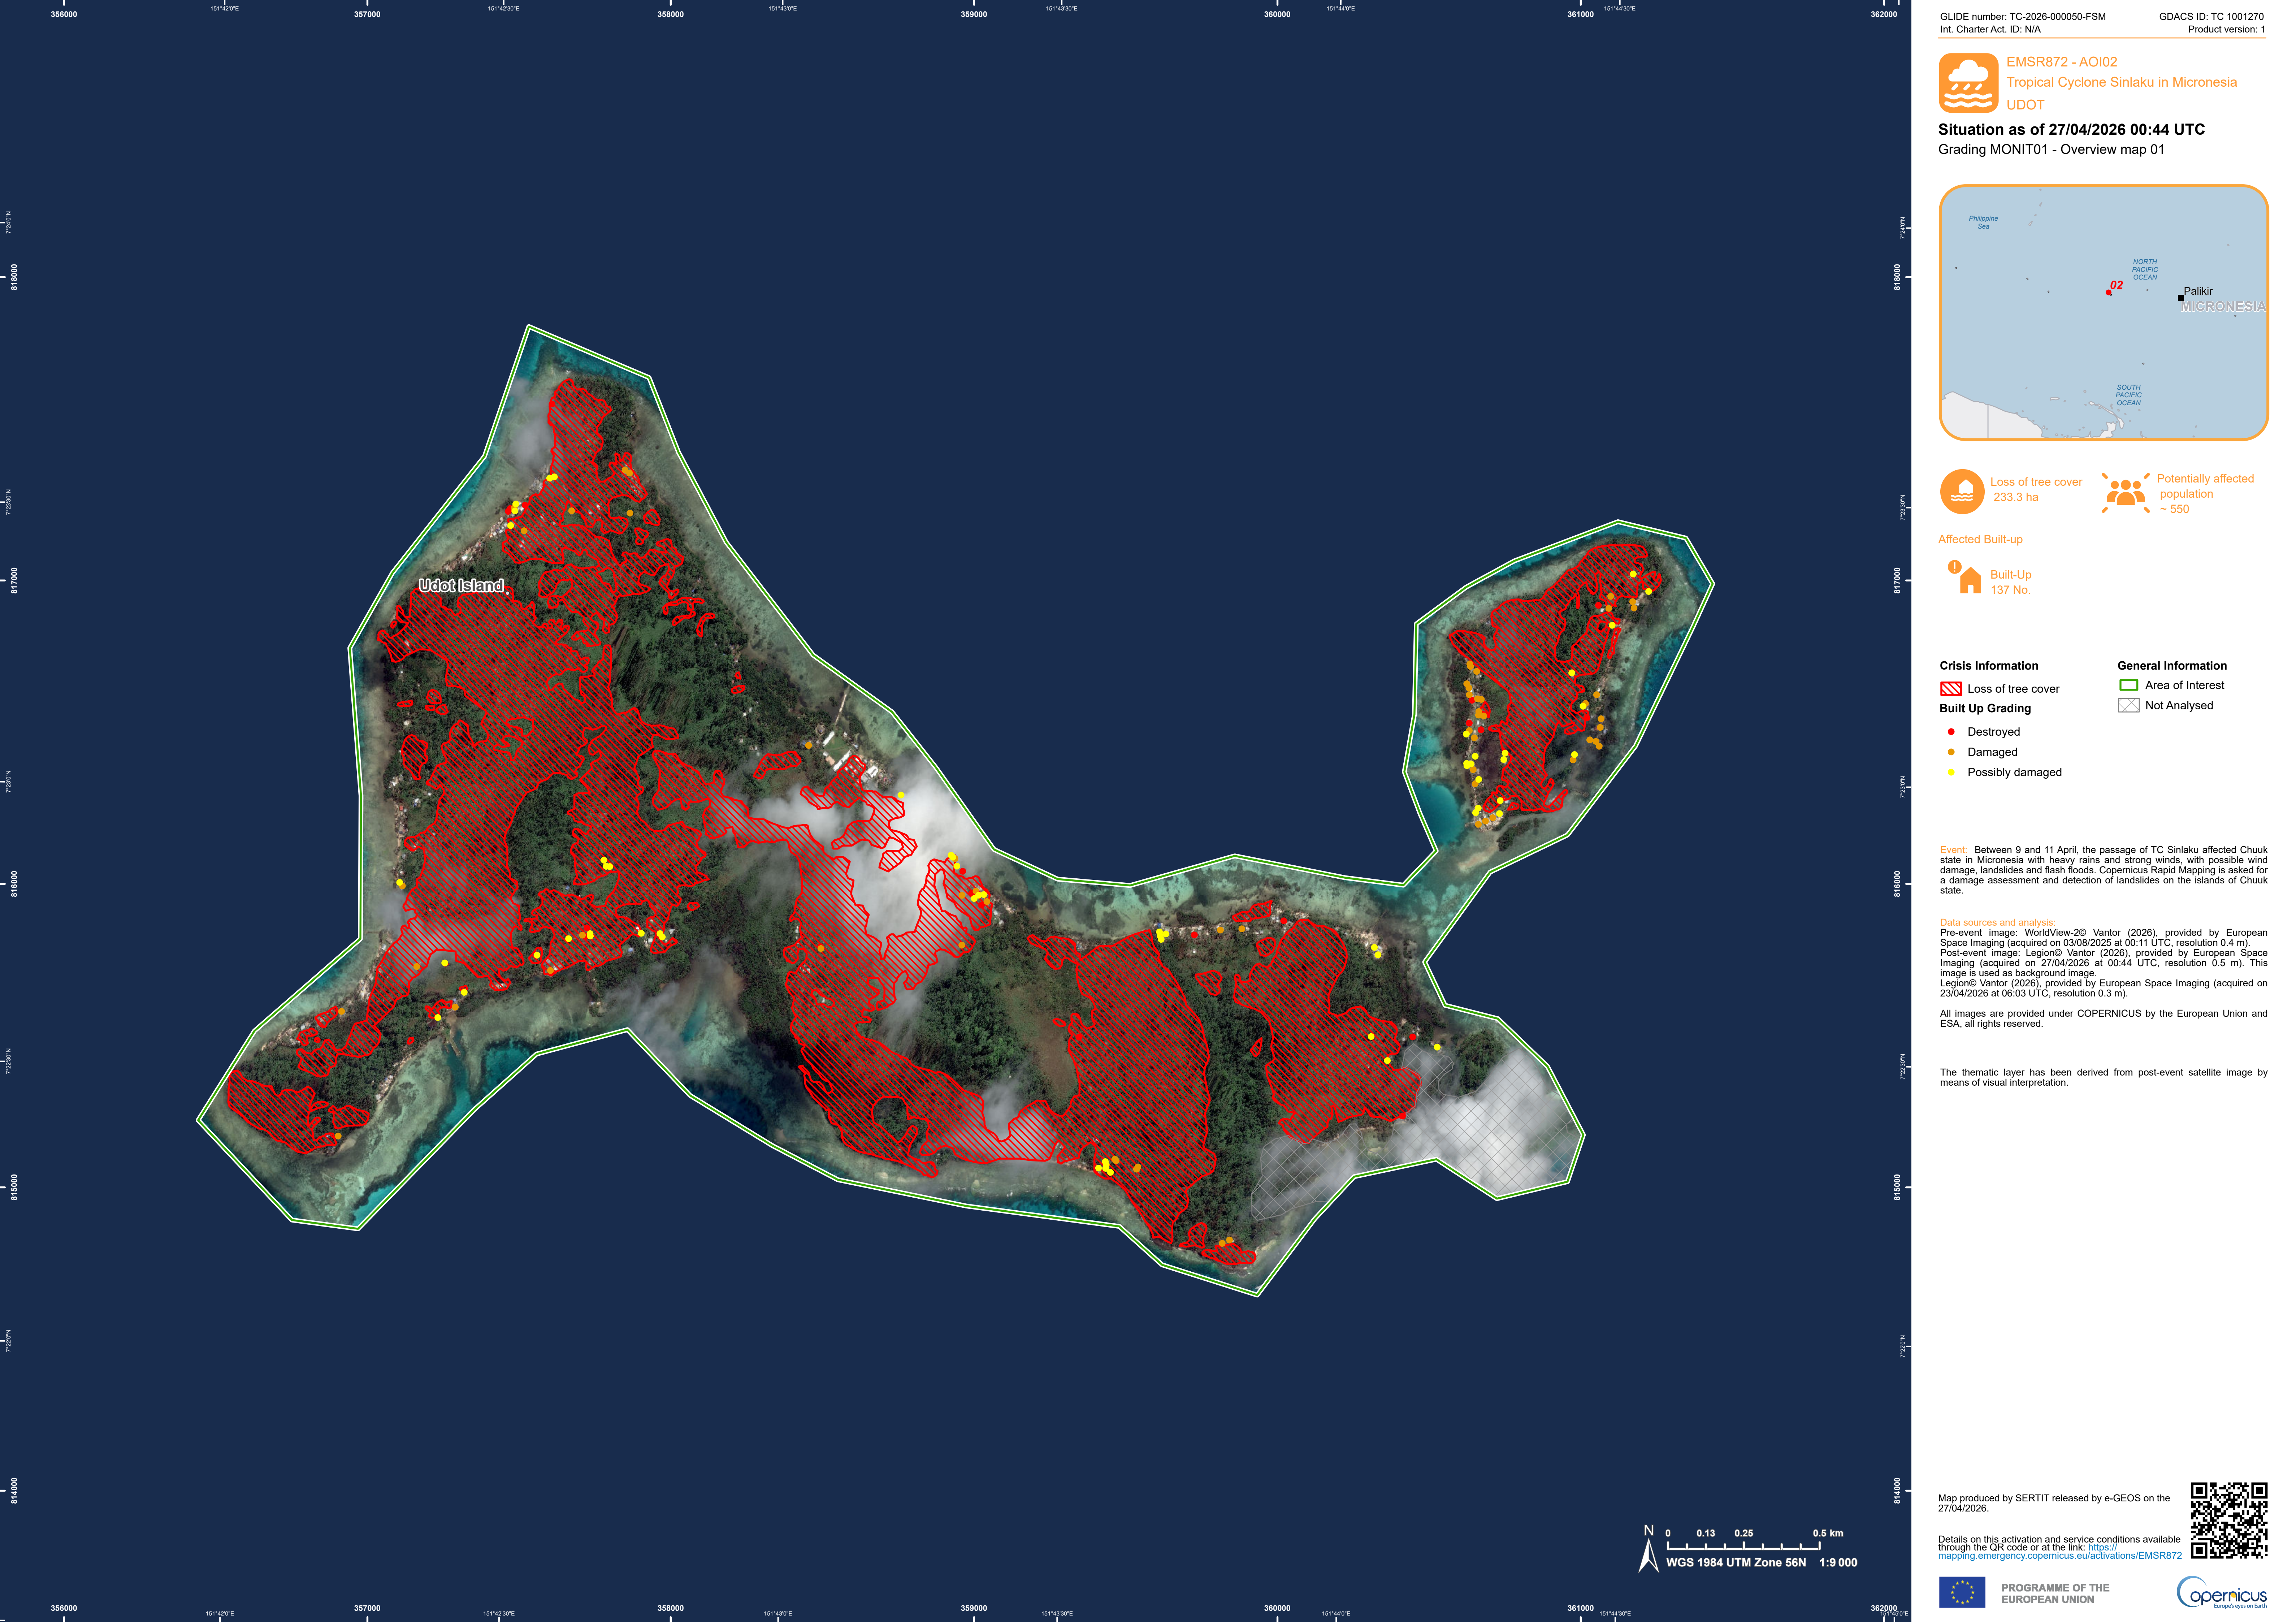
Loss of tree cover
233.3 ha

Potentially affected population
~ 550

Built-Up
137 No.

Event: Between 9 and 11 April, the passage of TC Sinlaku affected Chuuk state in Micronesia with heavy rains and strong winds, with possible wind damage, landslides and flash floods. Copernicus Rapid Mapping is asked for a damage assessment and detection of landslides on the islands of Chuuk state.

The thematic layer has been derived from post-event satellite image by means of visual interpretation.

Destroyed	Damaged	Possibly damaged*	Total affected**	Total in AOI
Estimated population		Inhabitants	No.				~ 550	~ 1 900
Assets	Built-up	Unclassified	No.	21	58	58	137	493
	Transportation	Cart Track	km	0	0	0	0	0.5
	Land use	Forests	ha				123.9	265.4
		Shrub and/or herbaceous vegetation association	ha				108.4	201.2
