**EMSR872 - AOI08**  
Tropical Cyclone Sinlaku in Micronesia  
TONOWAS

**Situation as of 17/04/2026 00:22 UTC**  
Grading - Overview map 01

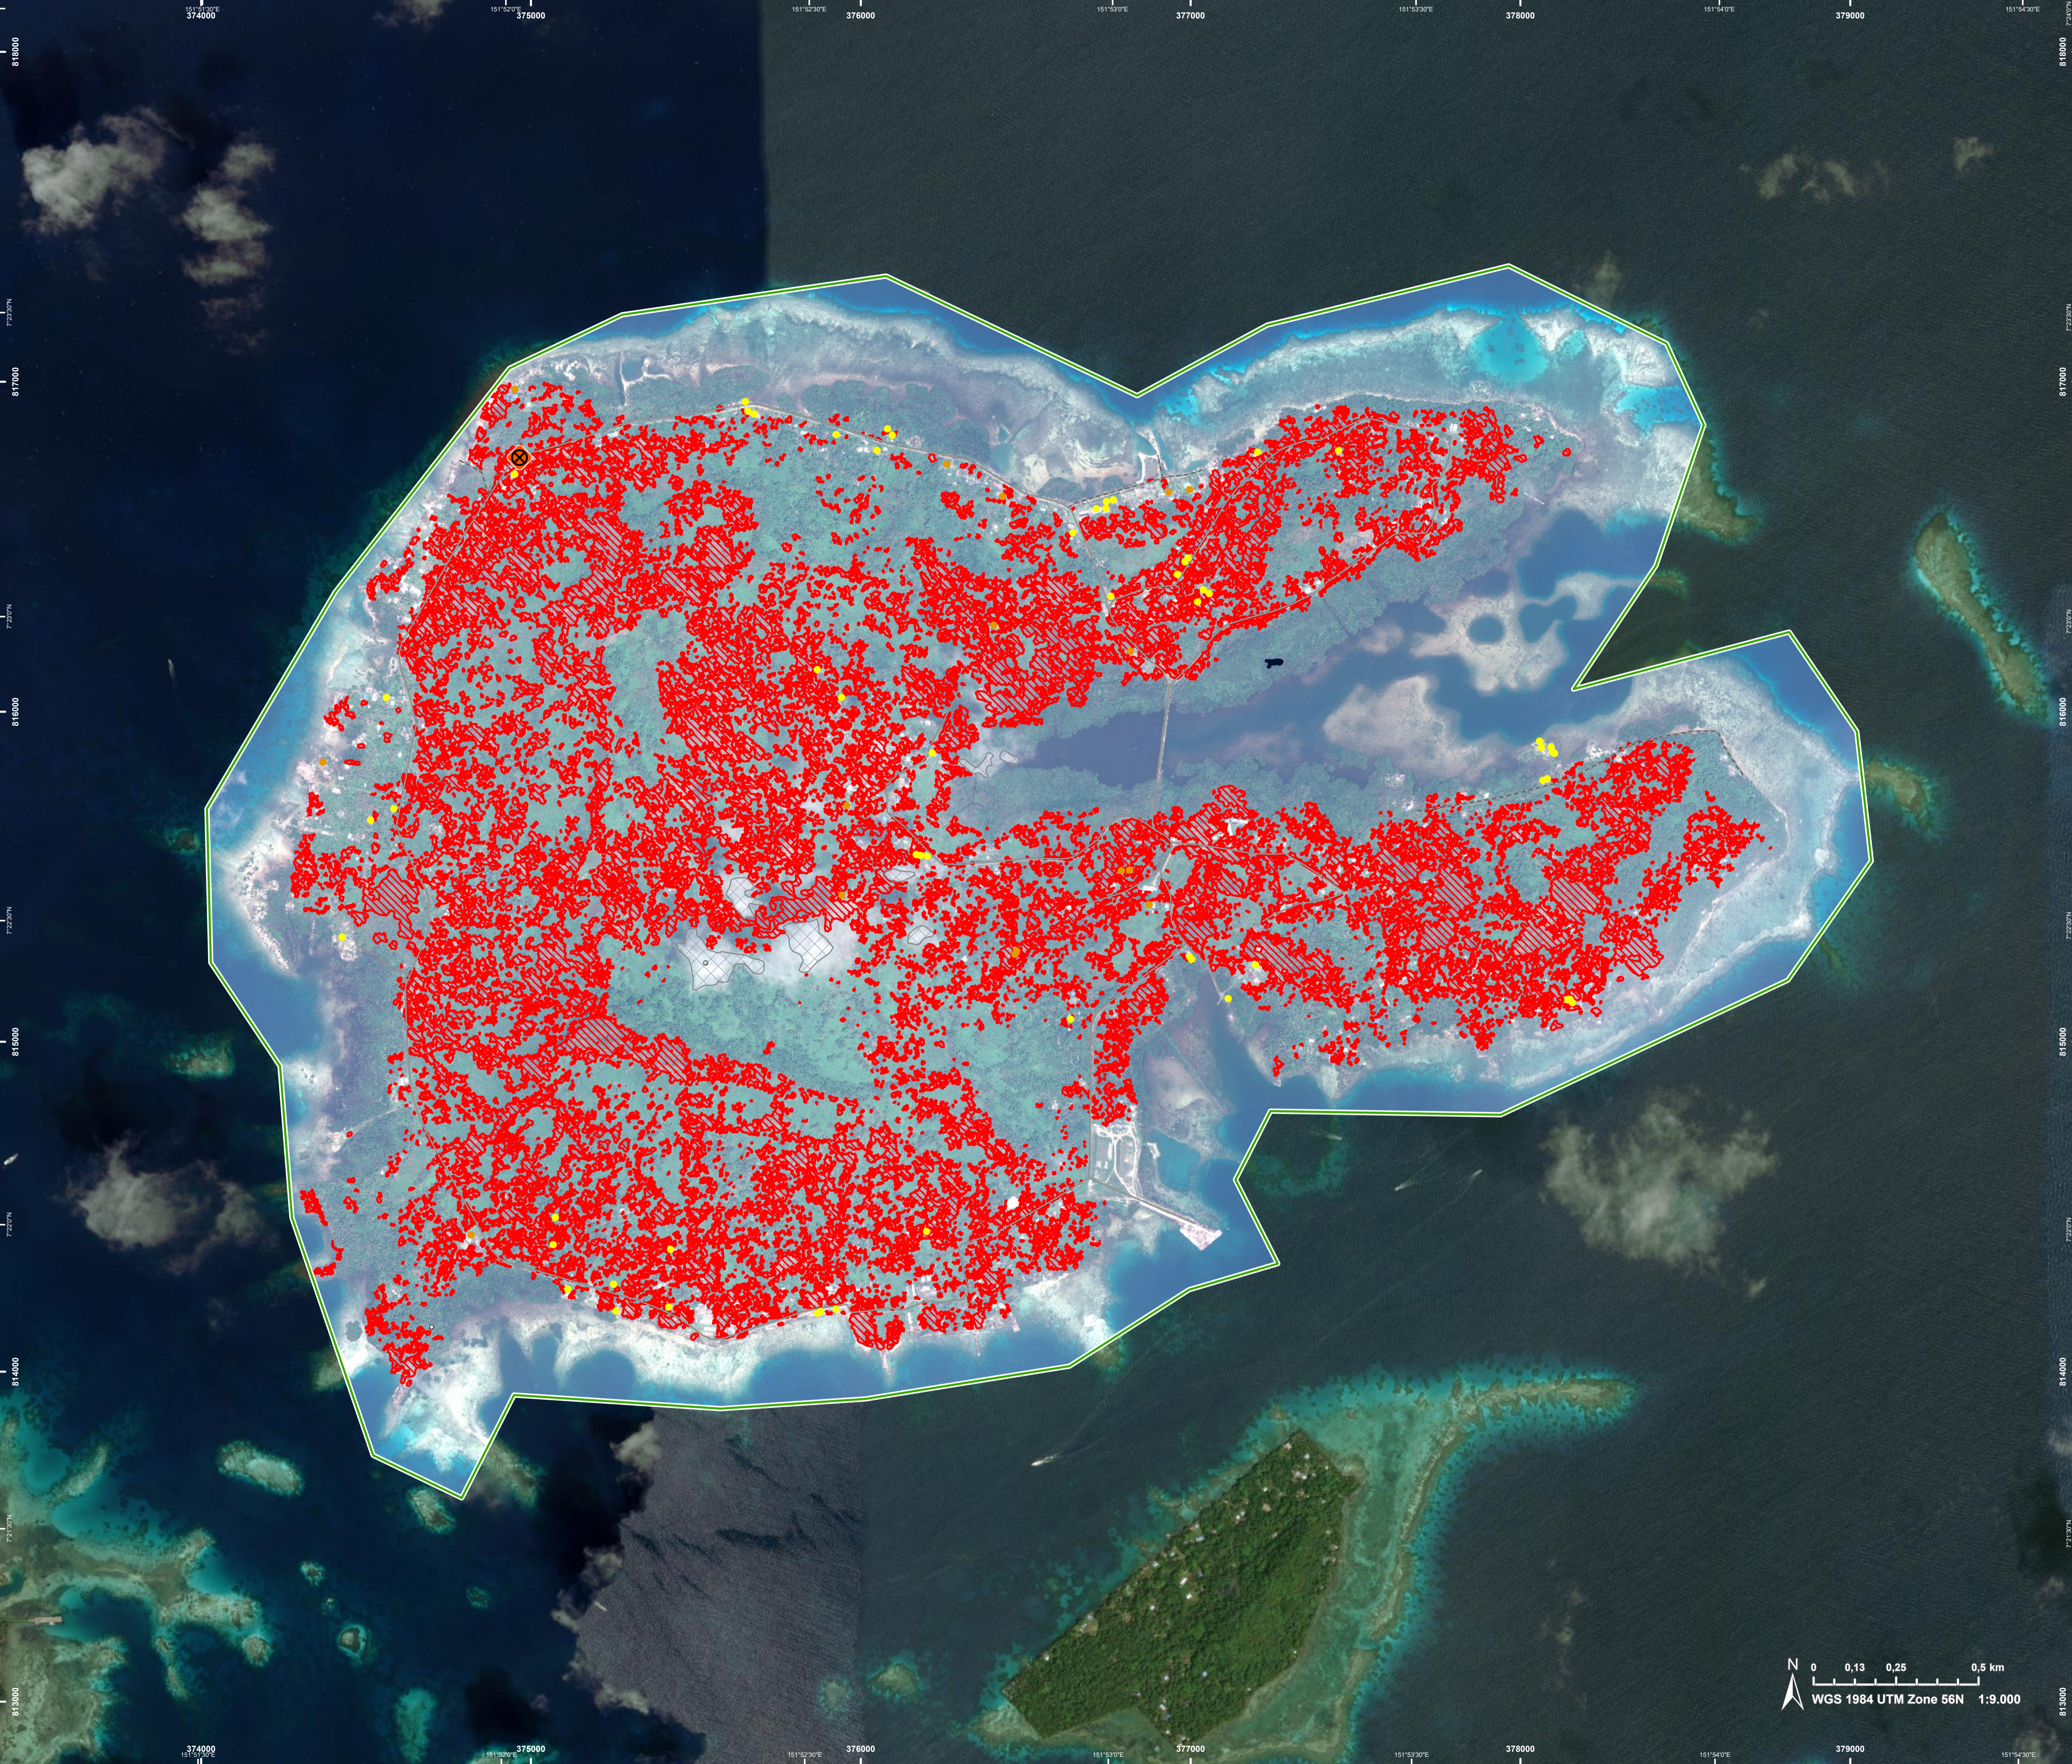
**Loss of tree cover**  
196.6 ha

**Potentially affected population**  
~ 650

**Built-Up**  
77 No.

**Event:** Between 9 and 11 April, the passage of TC Sinlaku affected Chuuk state in Micronesia with heavy rains and strong winds, with possible wind damage, landslides and flash floods. Copernicus Rapid Mapping is asked for a damage assessment and detection of landslides on the islands of Chuuk state.

The thematic layer has been derived from post-event satellite image by means of visual interpretation.

Destroyed	Damaged	Possibly damaged*	Total affected**	Total in AOI
Estimated population		Inhabitants	No.				~ 650	~ 3.200
Assets	Built-up	Residential Buildings	No.	0	16	60	76	1.002
		Other buildings not elsewhere classified	No.	0	0	1	1	3
	Transportation	Local Road	km	0	0	0	0	14,6
		Cart Track	km	0	0	0	0	1,7
	Land use	Forests	ha				121,0	575,7
		Shrub and/or herbaceous vegetation association	ha				73,1	298,2
		Open spaces with little or no vegetation	ha				0,5	2,3
