Situation as of 17/04/2026 00:23 UTC
Grading - Overview map 01

Event: Between 9 and 11 April, the passage of TC Sinlaku affected Chuuk state in Micronesia with heavy rains and strong winds, with possible wind damage, landslides and flash floods. Copernicus Rapid Mapping is asked for a damage assessment and detection of landslides on the islands of Chuuk state.

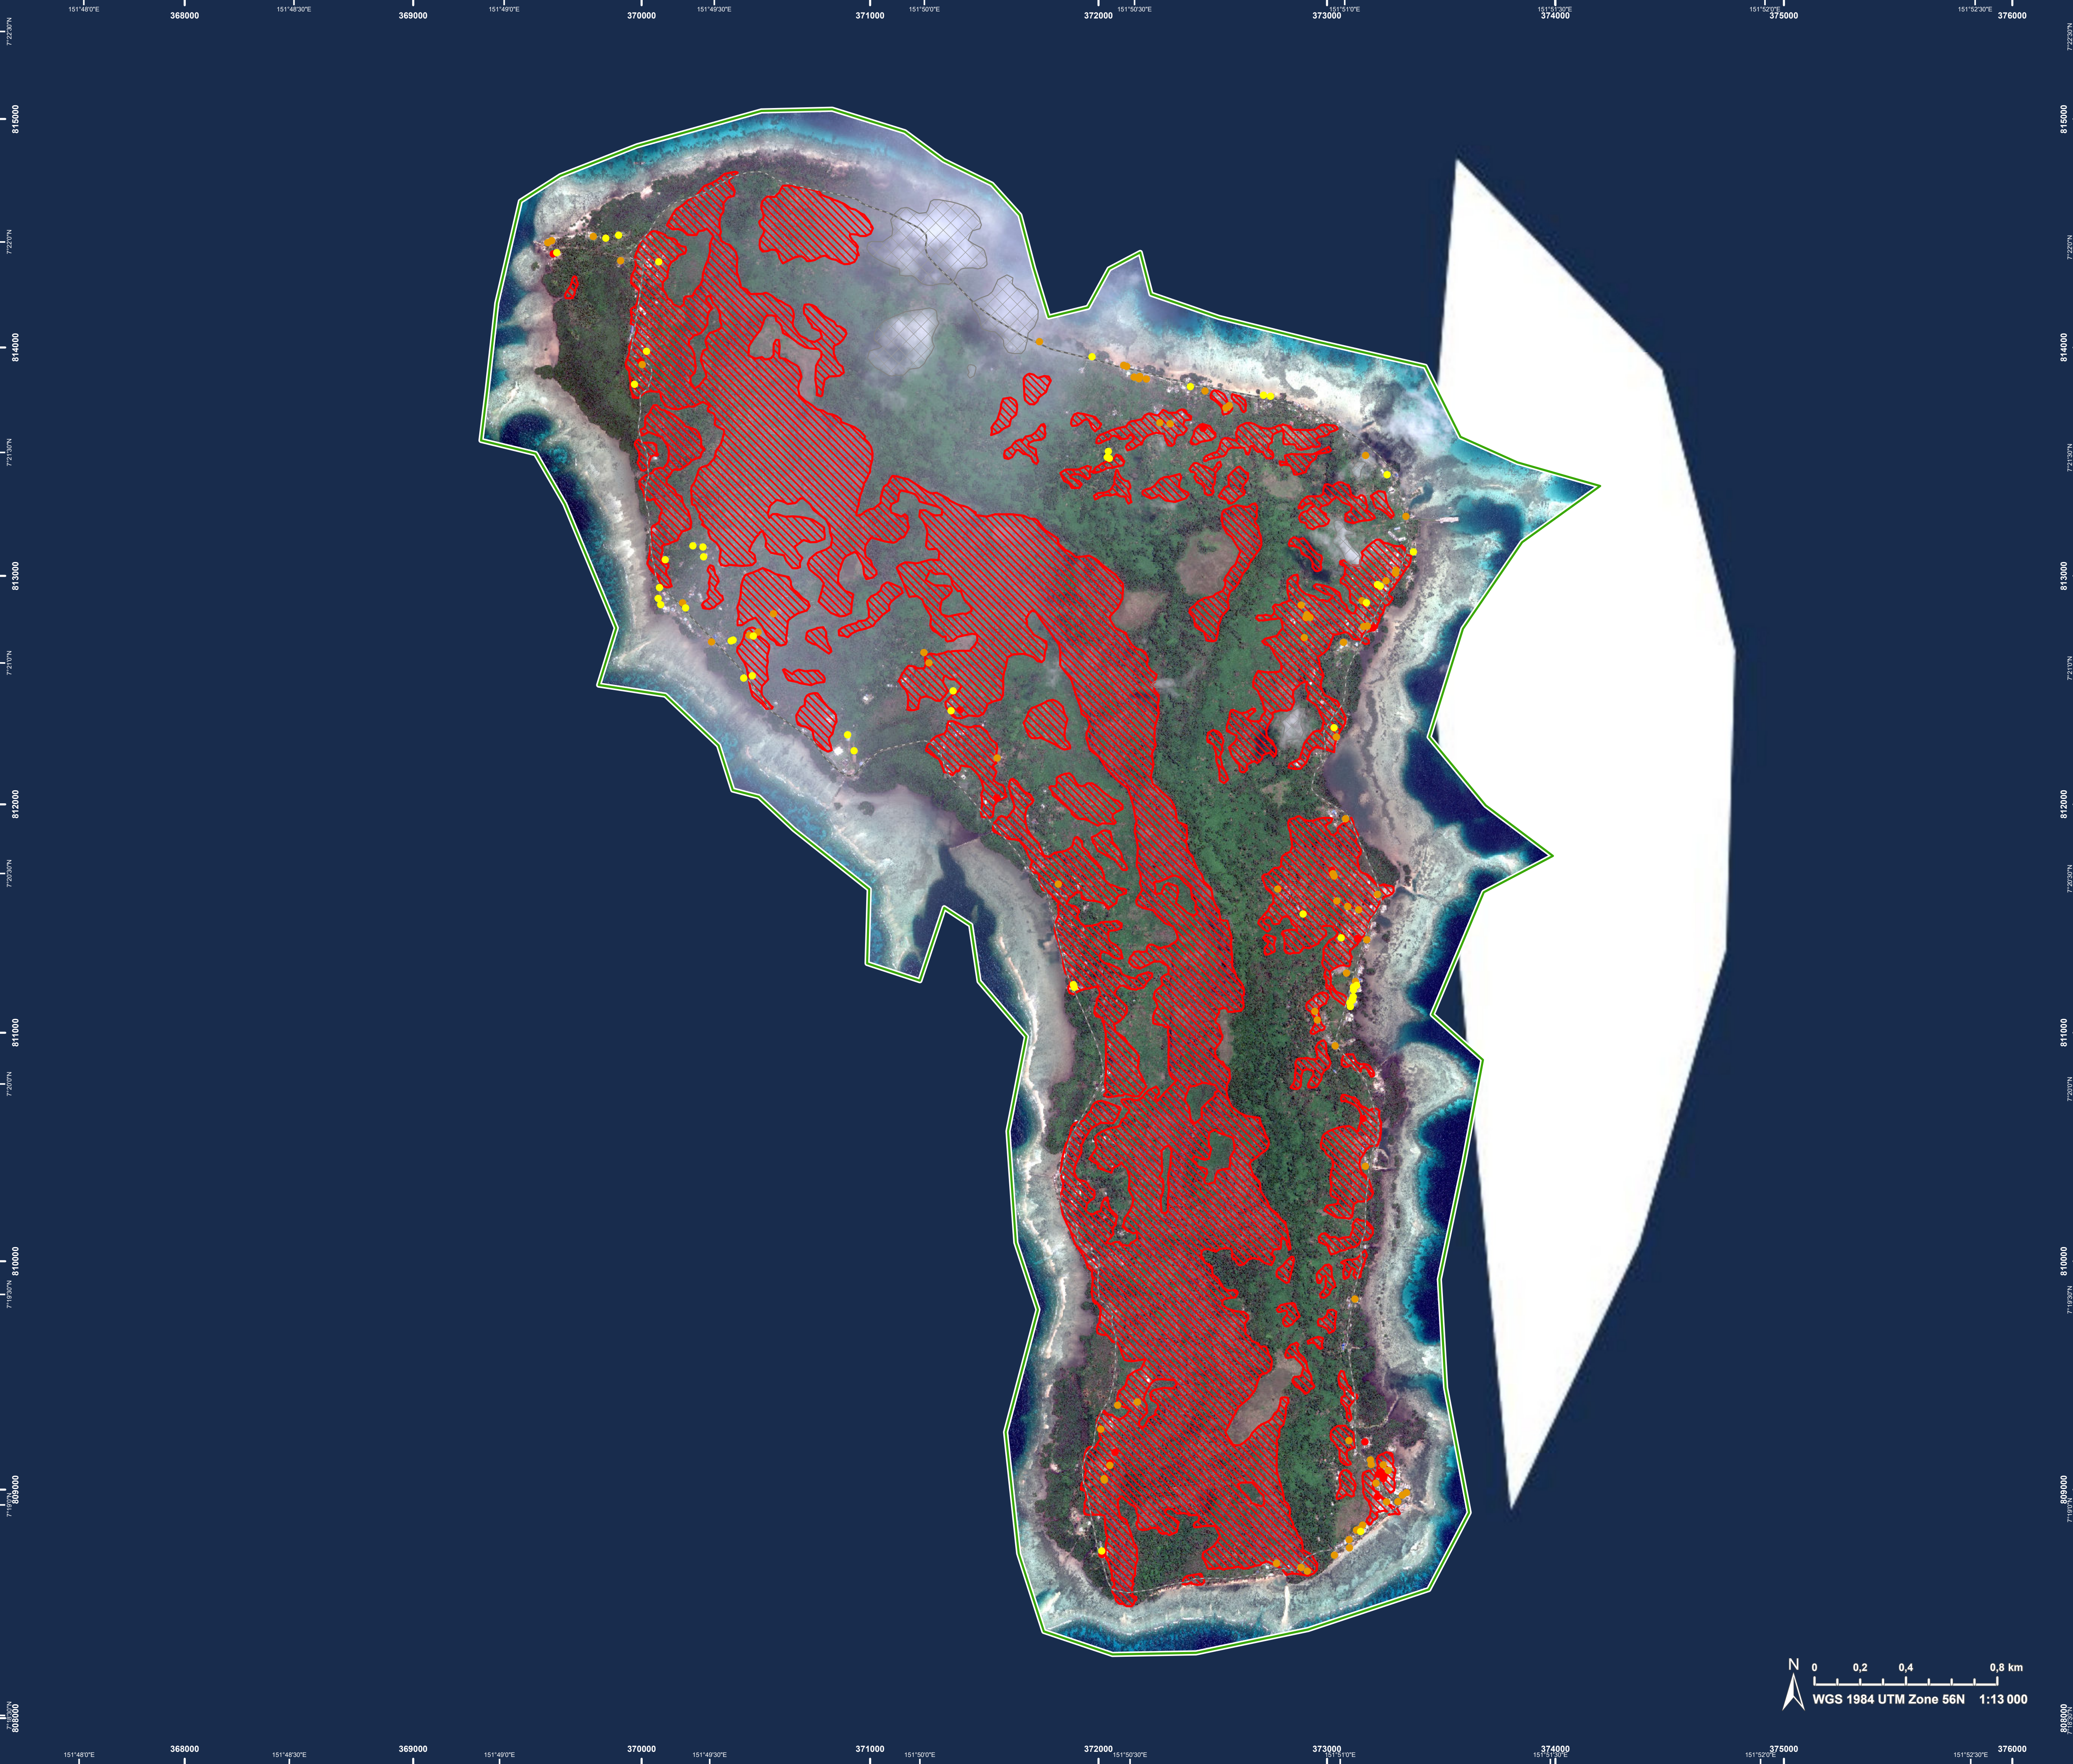
The thematic layer has been derived from post-event satellite image using by means of visual interpretation.

LATEST IMPACT	
			Unit of measurement	Imagery-based observation
Crisis information	Loss of tree cover		ha	512,6

Estimated population		Inhabitants	No.	Destroyed	Damaged	Possibly damaged*	Total affected**	Total in AOI
Assets	Built-up	Residential Buildings	No.	1	2	0	3	3
		Other non-residential buildings	No.	5	12	21	38	39
		Unclassified	No.	13	68	29	110	976
	Transportation	Cart Track	km	0	0	0	0	17,5
	Land use	Forests	ha				466,3	1 110,4
		Shrub and/or herbaceous vegetation association	ha				34,2	195,4

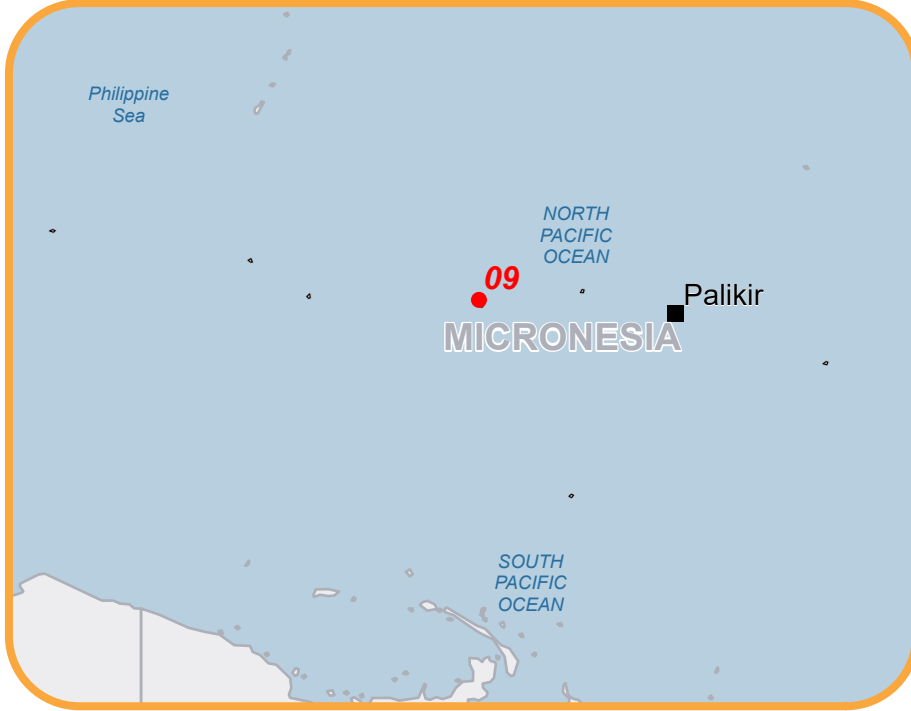
**Loss of tree cover**
512.6 ha

**Potentially affected population**
~ 1,000

**Built-Up**
151 No.
