EMSR695 - AOI04
Earthquake in Morocco
ASSAKOUI-IGHIL

Situation as of 10/09/2023 11:15 UTC

Grading - Overview map 01

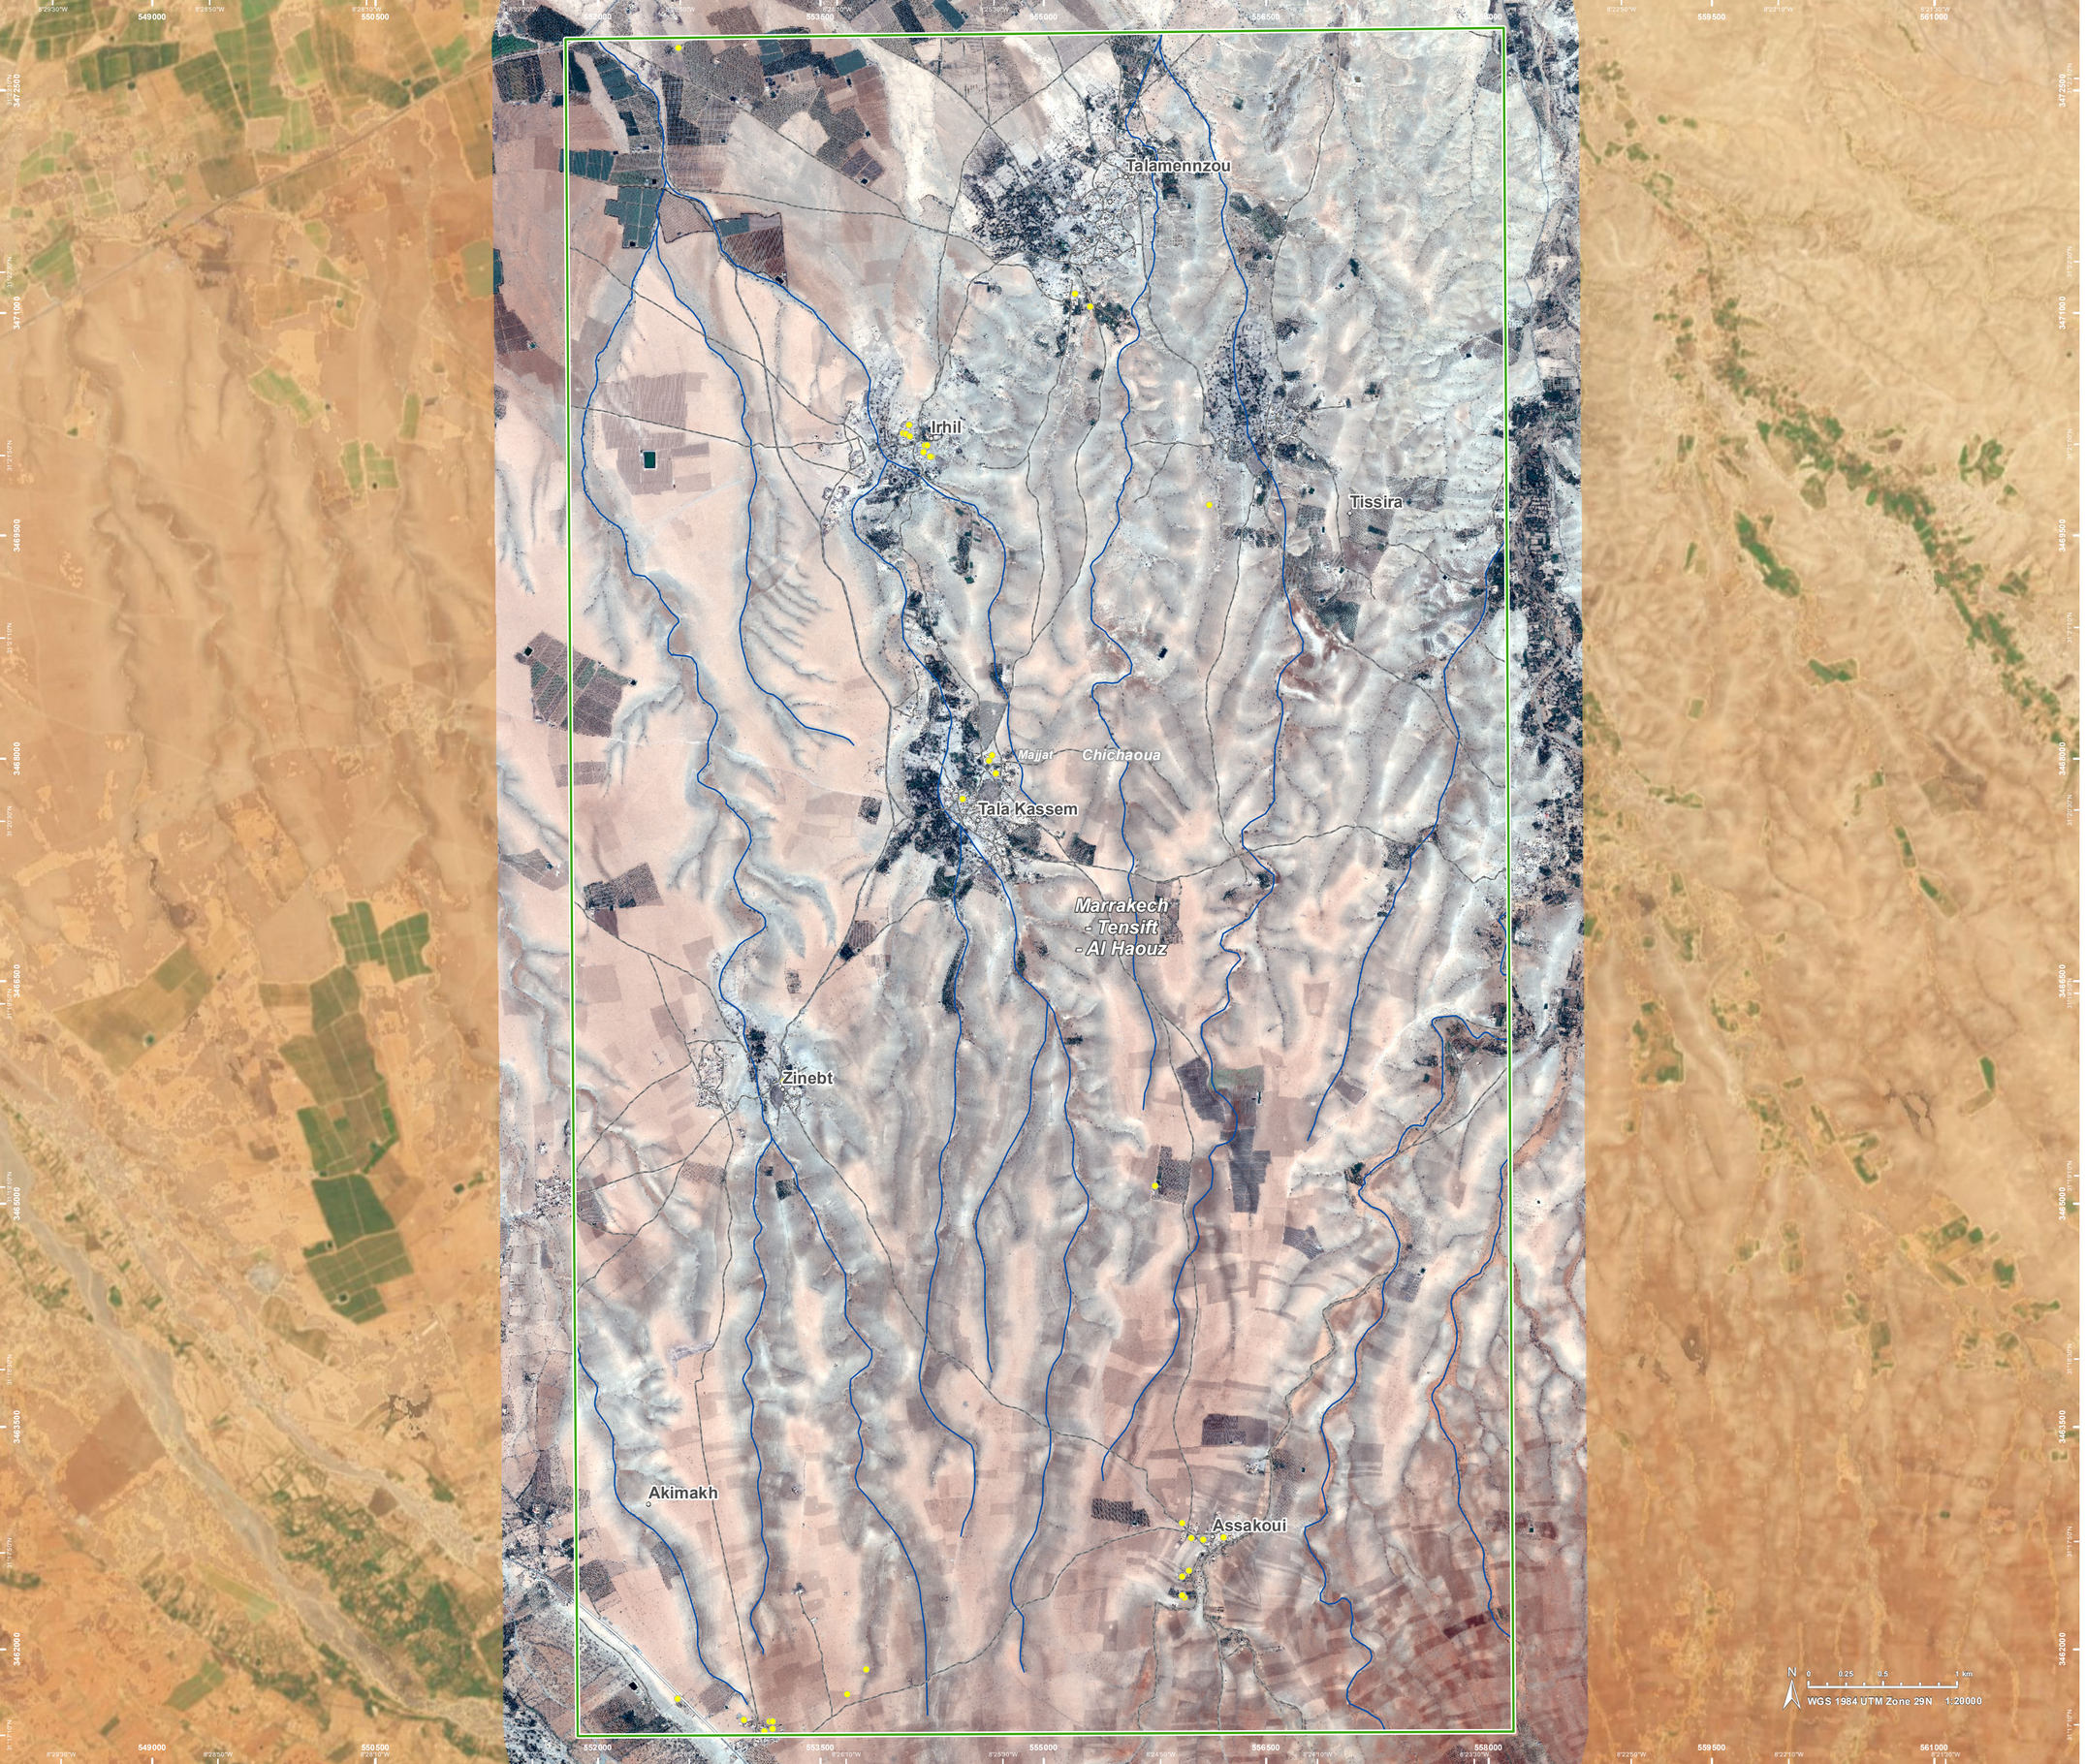
Built-Up
36 No.

Consequences within the AOI							
	Unit of measurement		Destroyed	Damaged	Possibly damaged*	Total affected**	Total in AOI
Estimated population	Number of inhabitants					NA	~ 3,300
Built-up	Residential Buildings	No.	0	0	36	36	1,546
Transportation	Secondary Road	km	0.0	0.0	0.0	0.0	1.4
	Cart Track	km	0.0	0.0	0.0	0.0	92.5
	Streets and roads	km	0.0	0.0	0.0	0.0	27.5
Land use	Heterogeneous agricultural areas	ha	0.0	0.0	0.0	0.0	2,749.7
	Forests	ha	0.0	0.0	0.0	0.0	3.6
	Shrub and/or herbaceous vegetation association	ha	0.0	0.0	0.0	0.0	4,437.3
	Other	ha	0.0	0.0	0.0	0.0	33.3
