EMSR899 - AOI01
Wildfire in Saumos, France
LE PORGE

Situation as of 01/08/2026 11:38 UTC

Grading MONIT01 - Overview map 01

EMSR899 AOI: 01 Le Porge Grading-Monit01

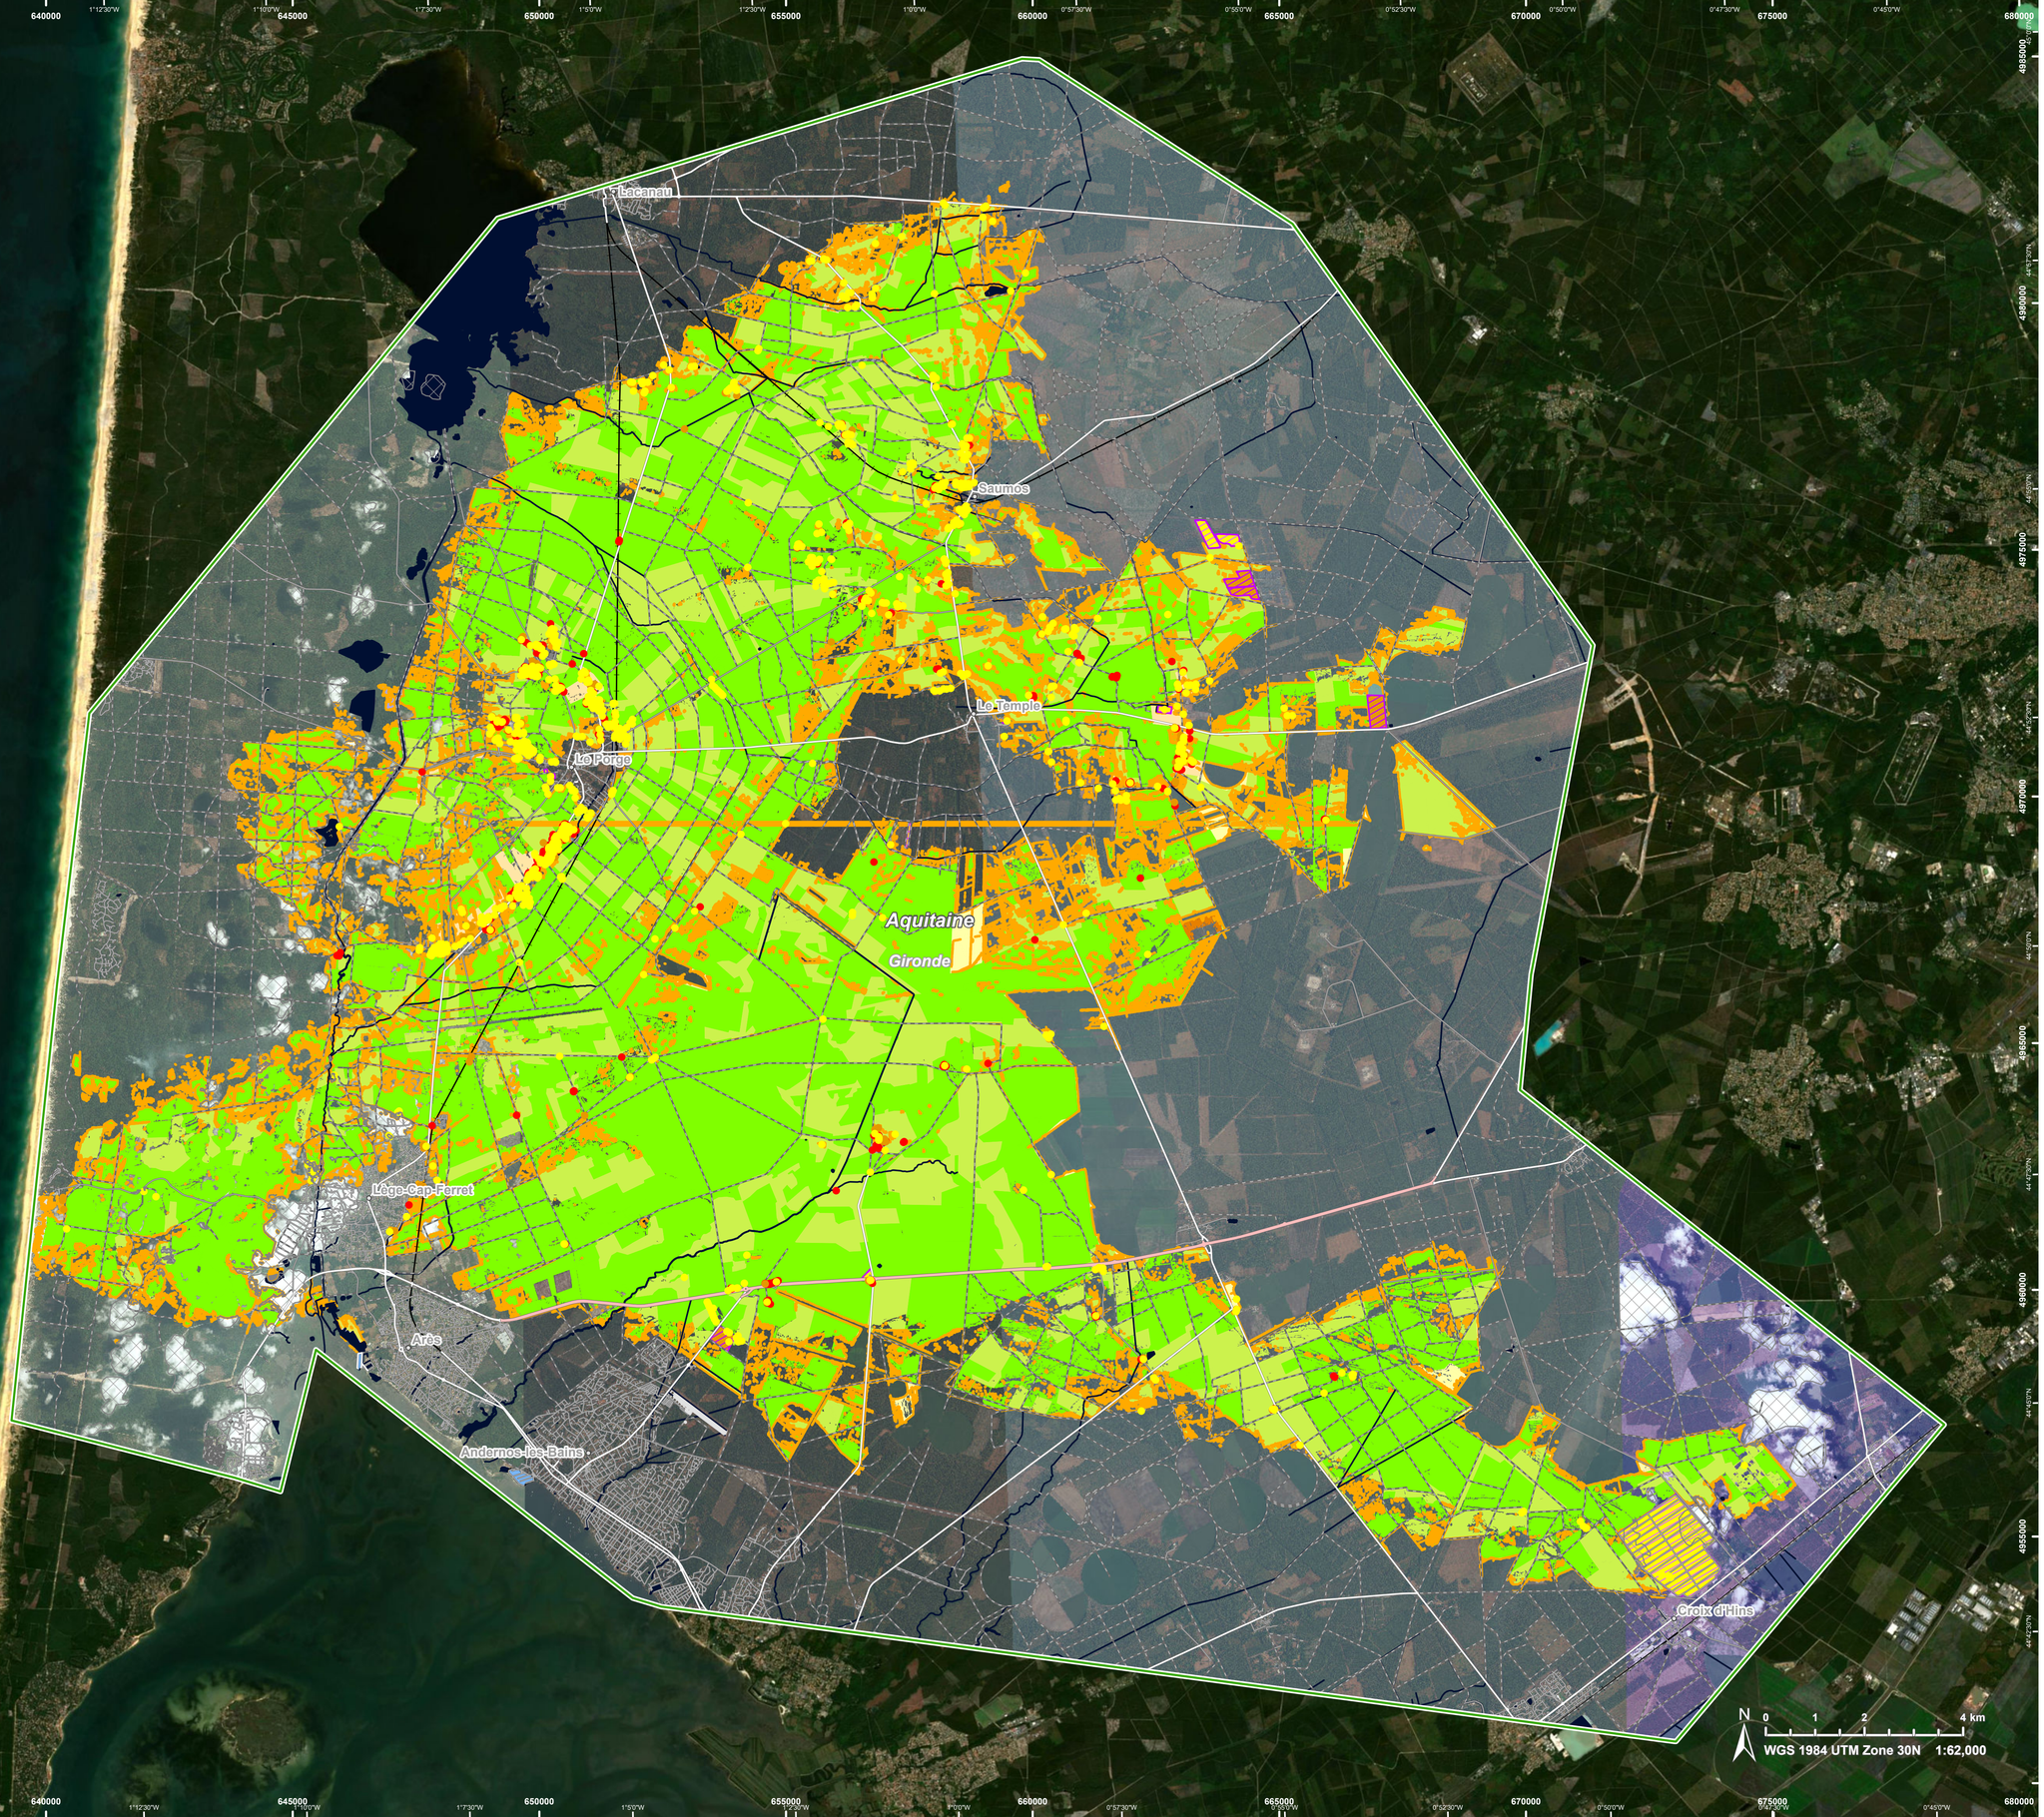
Burnt area
31,326.5 ha

Potentially affected population
~ 1,600

Built-Up
1,398 No.

Event: On 22 July 2026 at 18:00, a wildfire was reported to have affected Saumos, in the Nouvelle-Aquitaine region, France. The fire is ongoing and poses a significant threat to local communities, critical infrastructure, forests and nearby natural resources. Current weather conditions may favour its rapid spread, with possible population displacement and severe environmental damage. Copernicus EMS Rapid Mapping is requested to provide wildfire extent mapping and damage assessment emergency mapping.
