**EMSR882 - AOI02**  
Earthquake in the southern Philippines  
KIAMBA

**Situation as of 14/06/2026 02:24 UTC**  
Grading - Overview map 01

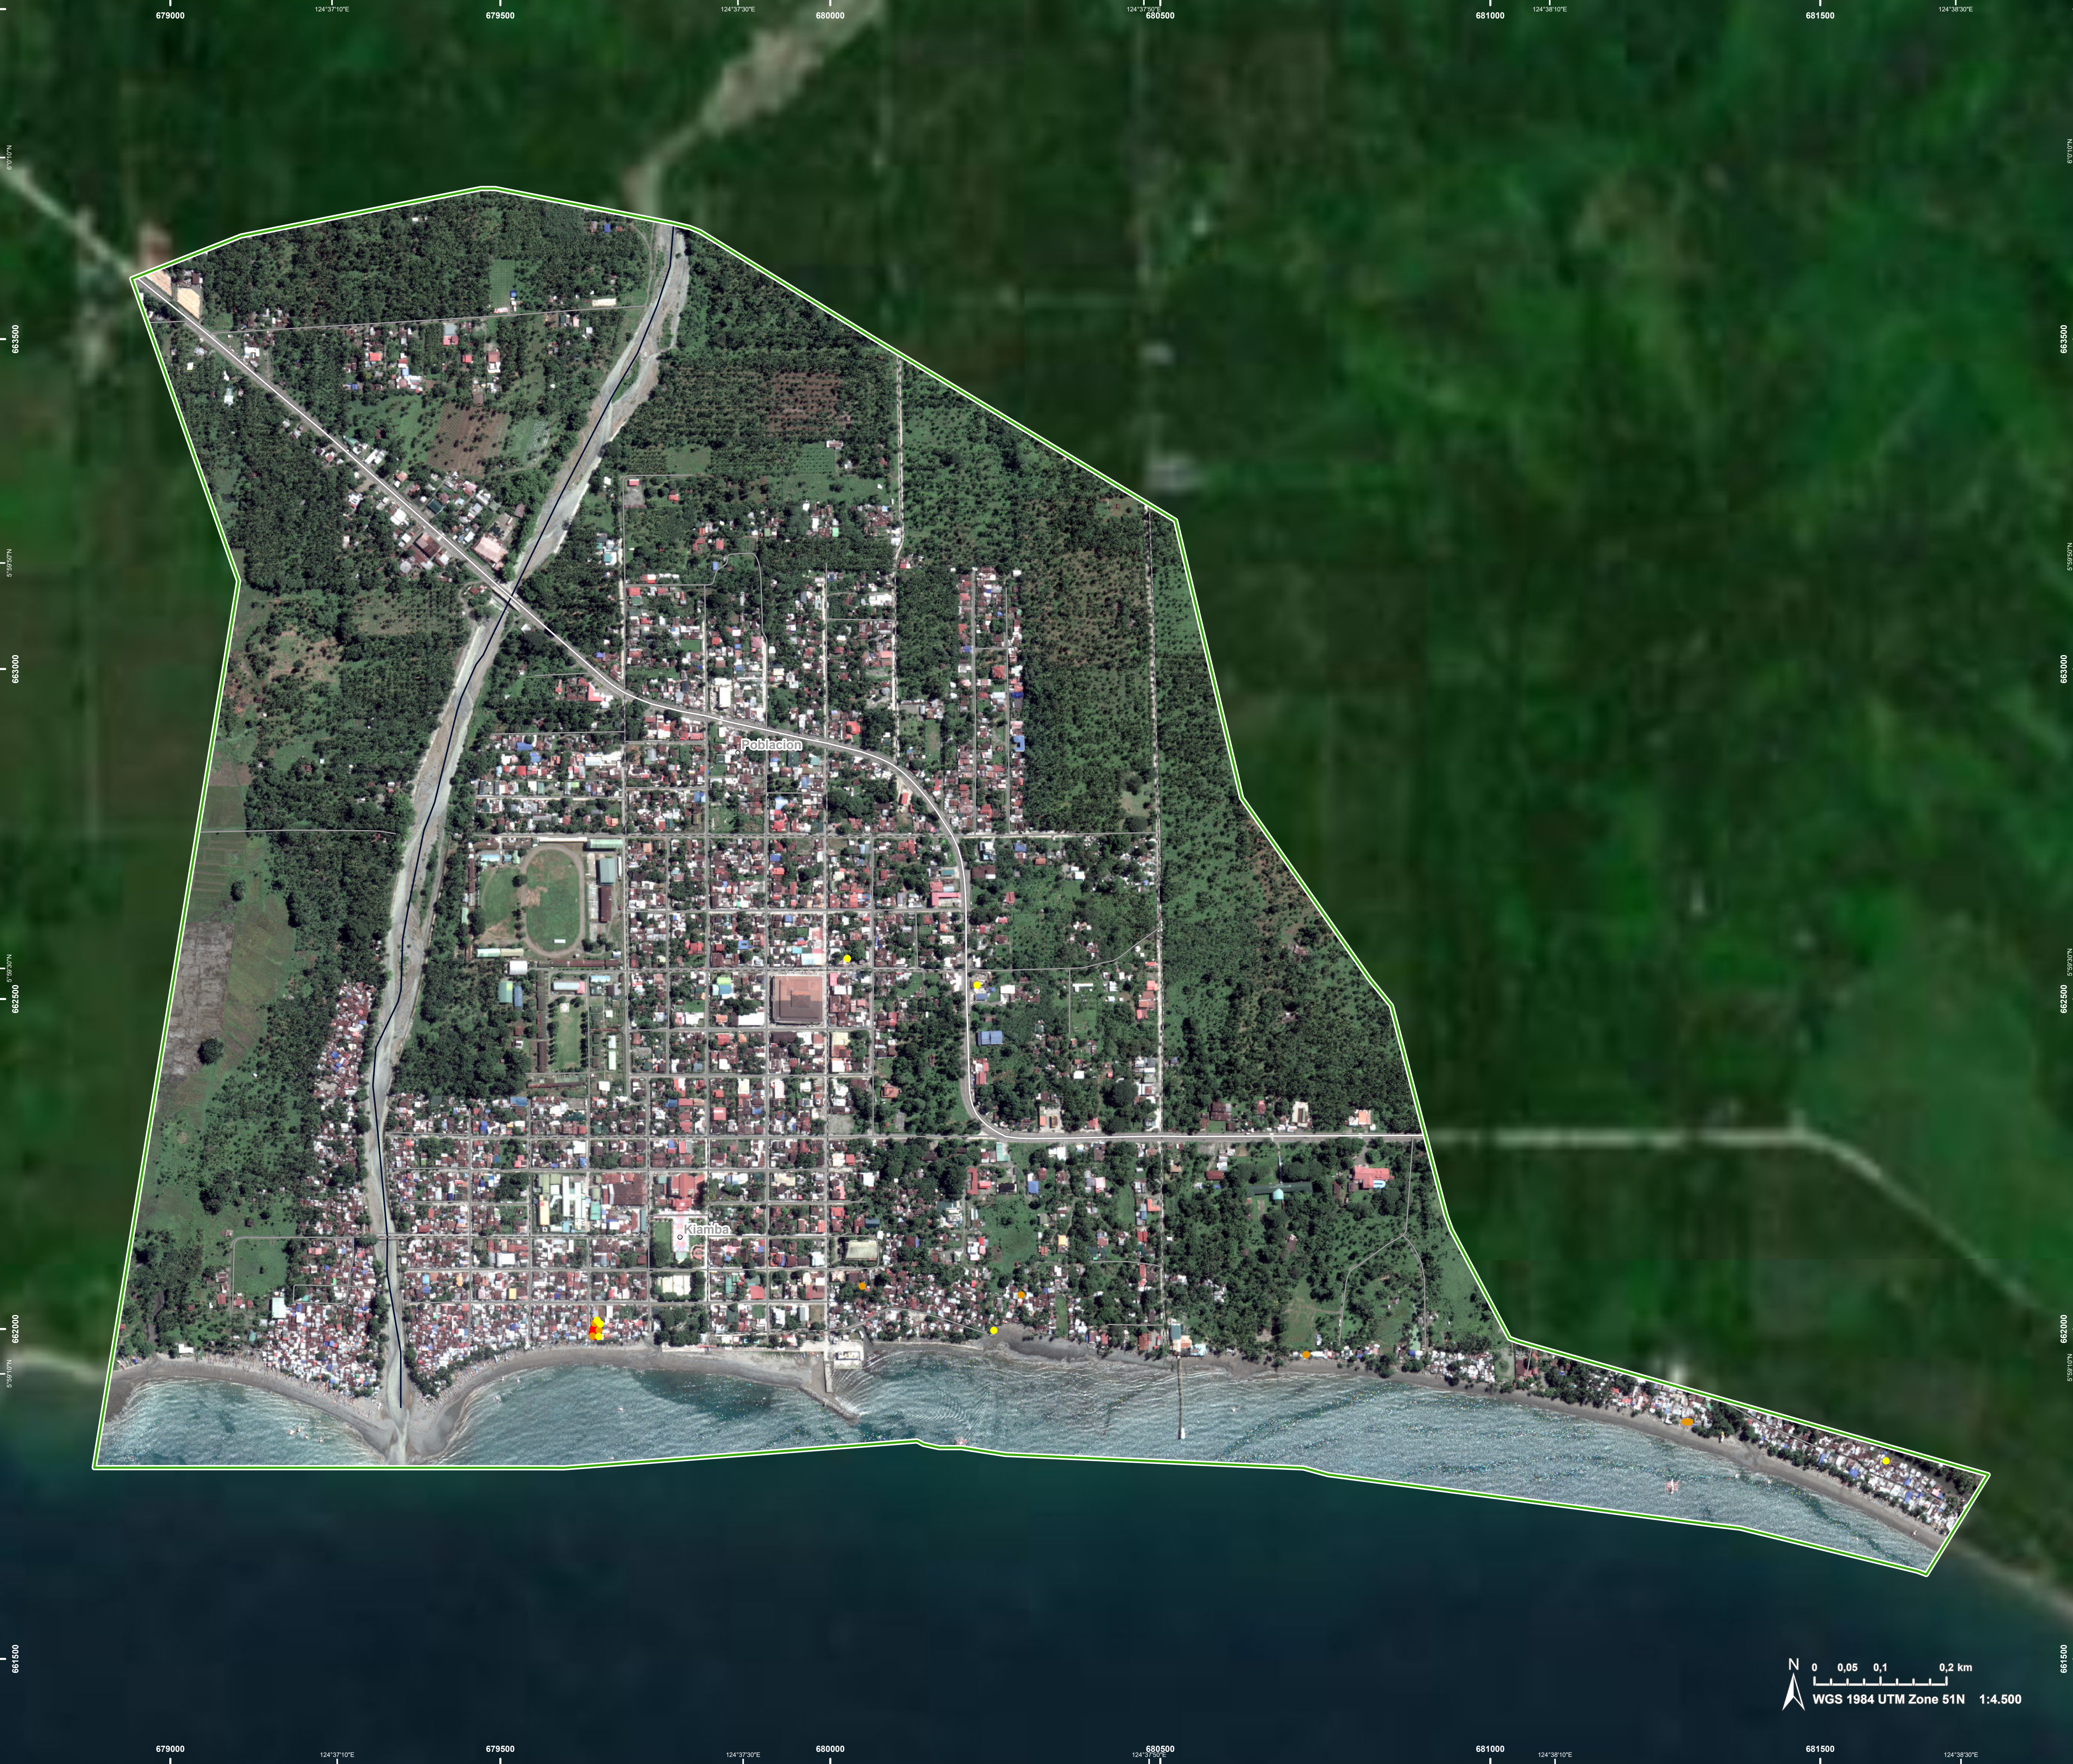
**Affected Built-up and Transportations**

**Built-Up**  
18 No.

- Built Up Grading**
- Destroyed
  - Damaged
  - Possibly damaged
- Transportation Grading**
- Main road, No visible damage
  - Local road, No visible damage
  - Track, No visible damage
- General Information**
- Area of Interest
- Hydrography**
- Lake, River

The thematic layer has been derived from post-event satellite image by means of visual interpretation.

| Estimated population | | Inhabitants | No. | Destroyed | Damaged | Possibly damaged* | Total affected** | Total in AOI |
|---|---|---|---|---|---|---|---|---|
| Assets | Built-up | Residential Buildings | No. | 3 | 8 | 7 | NA | ~ 18,000 |
| | | Other non-residential buildings | No. | 0 | 0 | 0 | 18 | 3,742 |
