EMSR884 - AOI06  
Earthquake in Venezuela  
MORON

Situation as of 26/06/2026 15:11 UTC  
Grading MONIT01 - Overview map 01

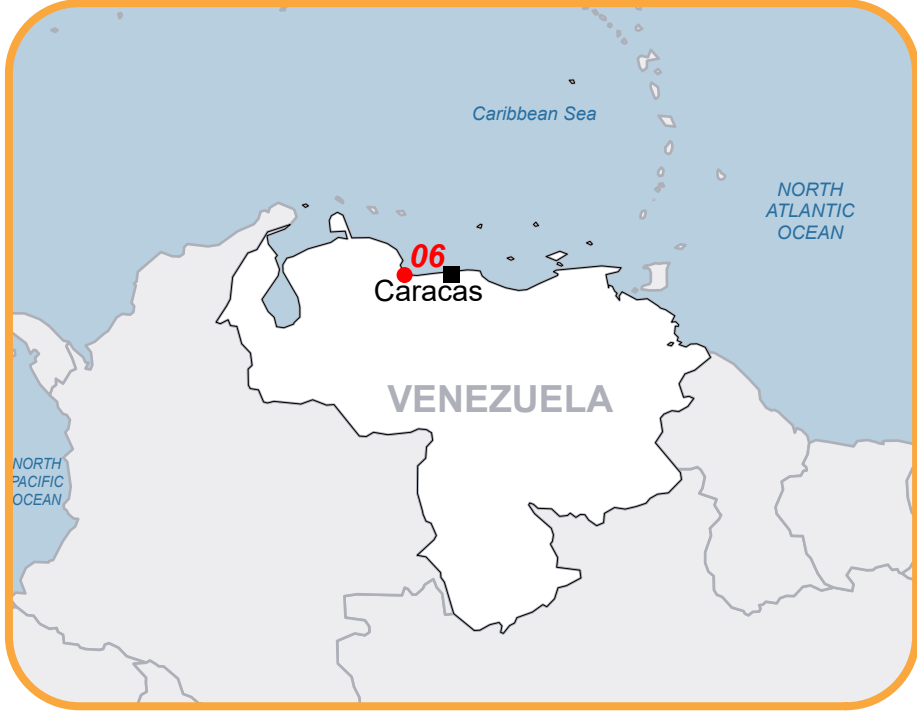
Built-Up  
96 No.

Destroyed

Damaged

Possibly damaged

**Event:** On 24 Jun 2026 22:05 UTC a 7.5M earthquake, preceded by a strong foreshock, occurred in Venezuela. The impact on population is deemed high at this stage, with low visibility on the extent of the damage. Copernicus EMS Rapid Mapping is requested to provide damage assessment emergency mapping.

| Estimated population | | Inhabitants | No. | Destroyed | Damaged | Possibly damaged* | Total affected** | Total in AOI |
|---|---|---|---|---|---|---|---|---|
| Assets | Built-up | Unclassified | No. | 8 | 39 | 49 | 96 | ~ 34,000 |
