**EMSR884 - AOI06**  
**Earthquake in Venezuela**  
**MORON**

**Situation as of 25/06/2026 20:36 UTC**  
Grading - Overview map 01

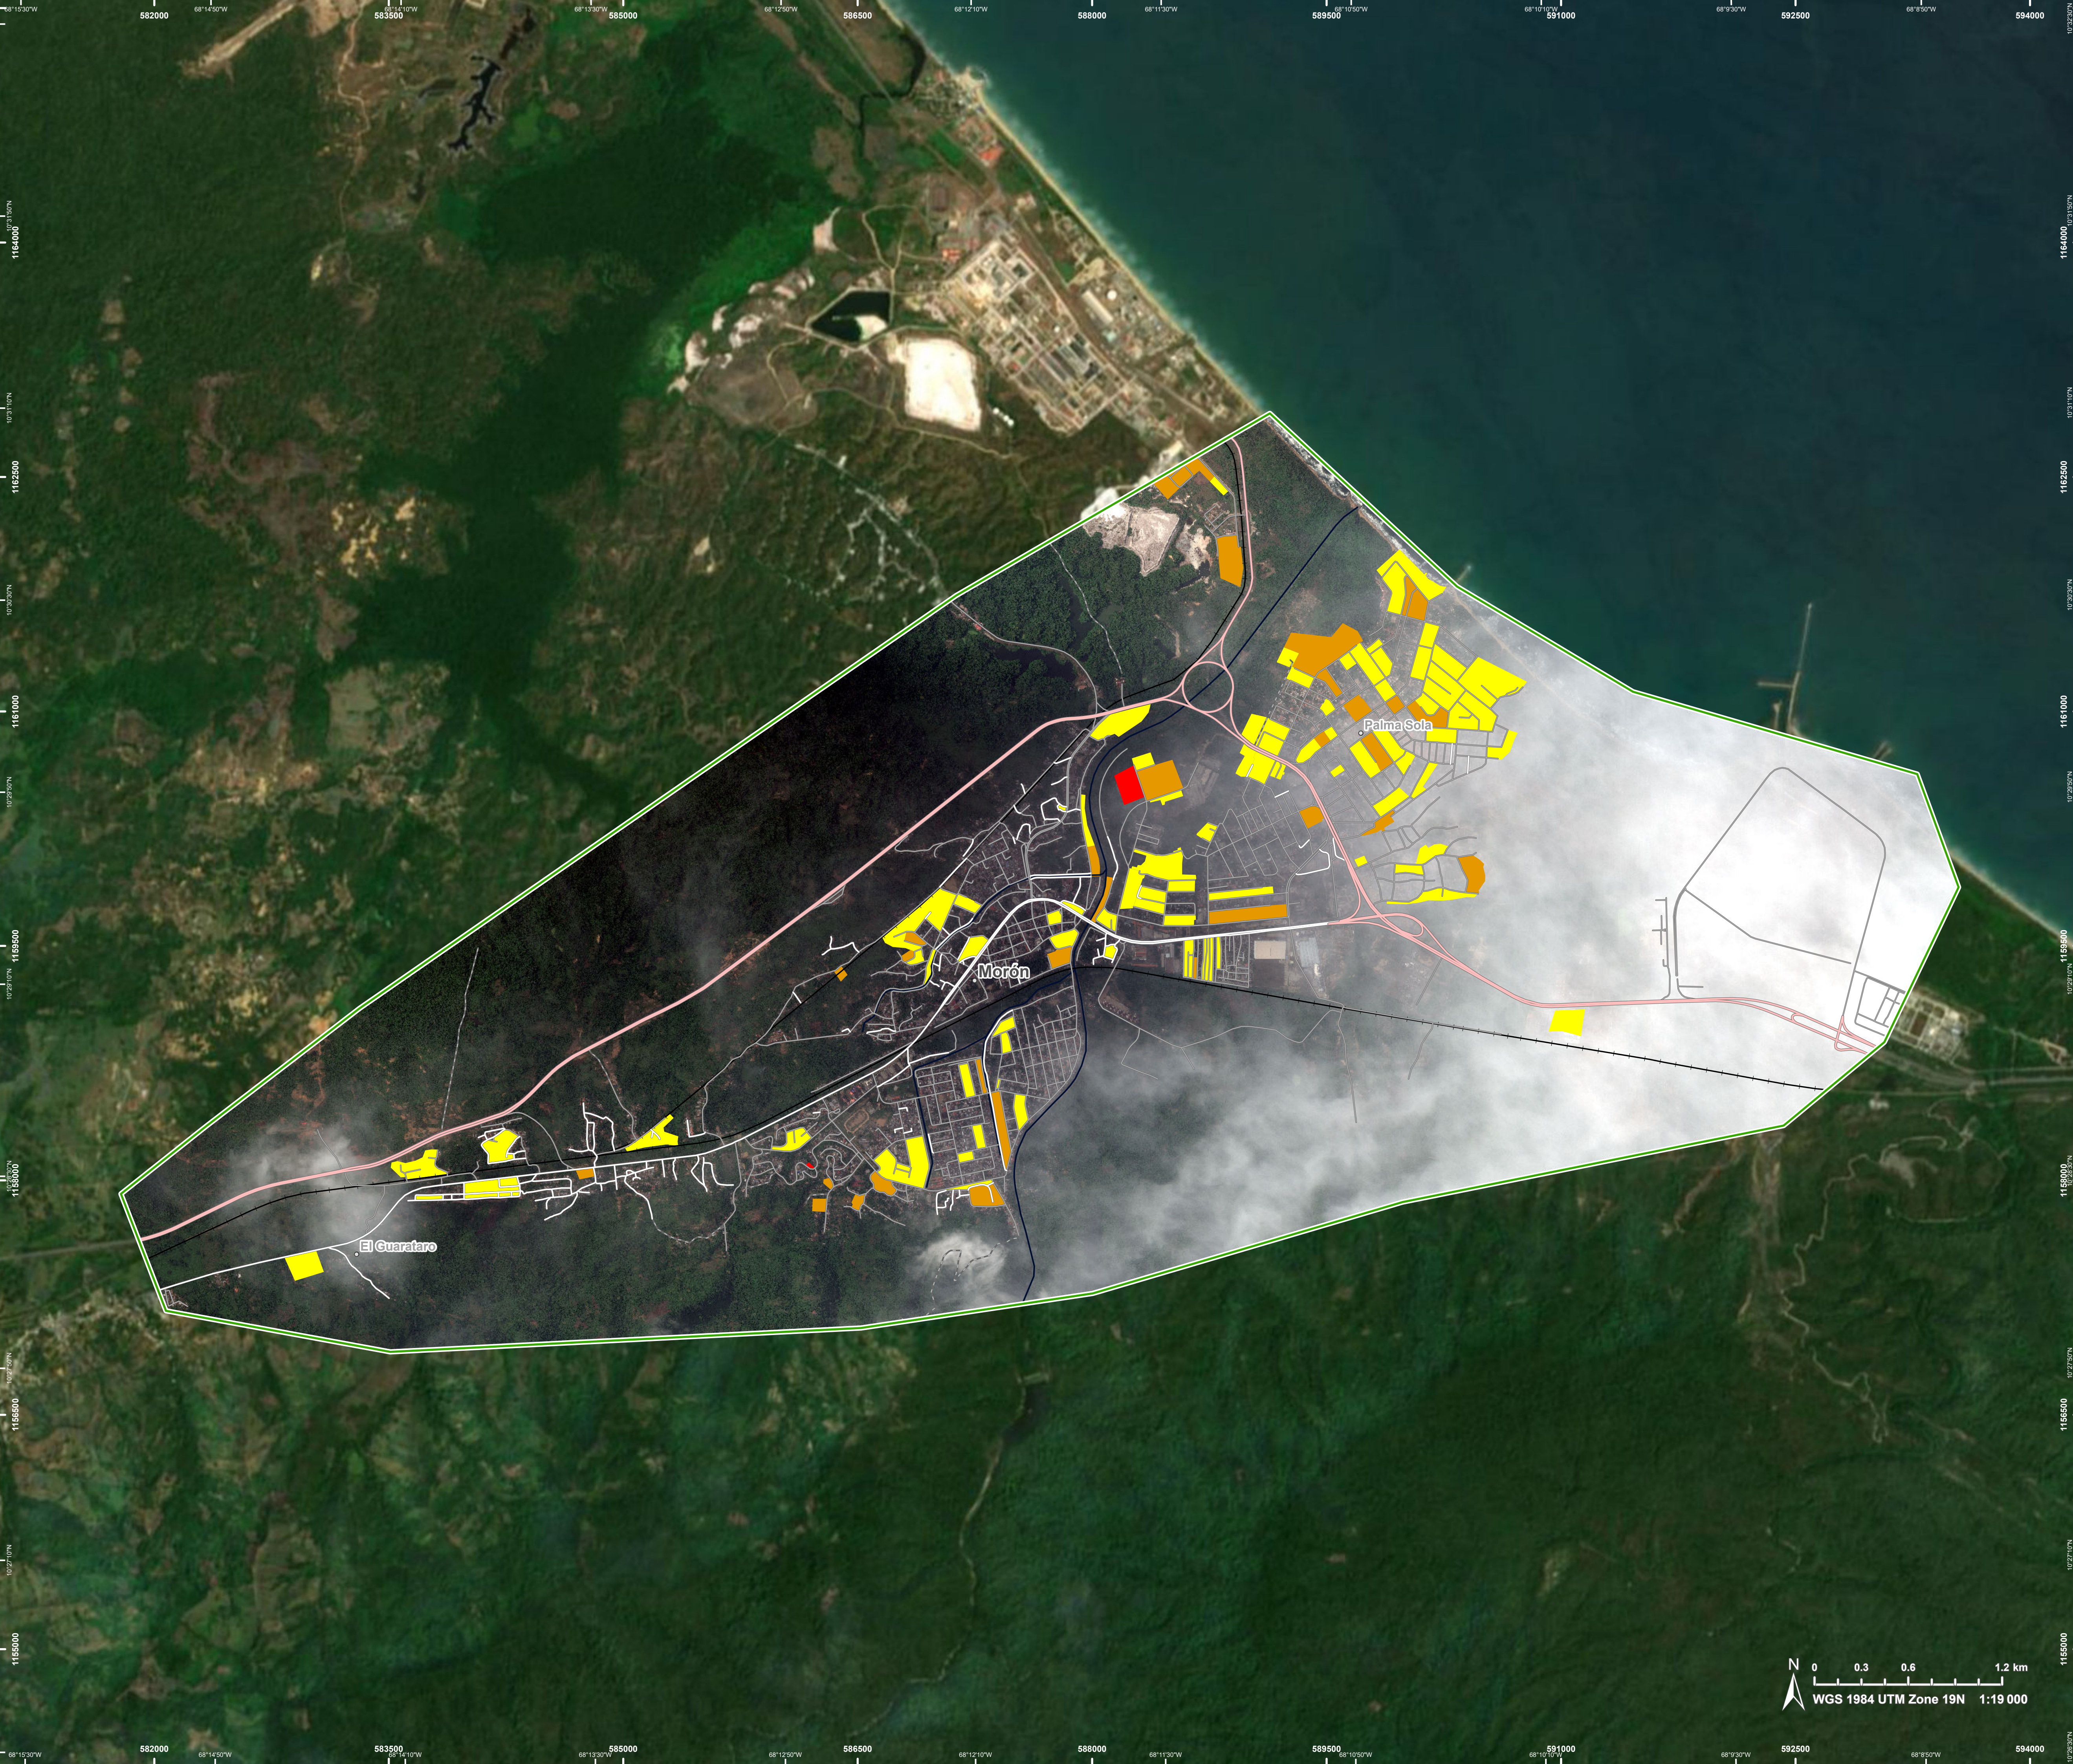
**Affected Built-up**  
**Built-Up**  
204.1 ha

**Built Up Grading**  
Destroyed  
Damaged  
Possibly damaged

**Transportation Grading**  
Highway, No visible damage

Main road, No visible damage  
Local road, No visible damage  
Track, No visible damage  
Railway, No visible damage

**Event:** On 24 Jun 2026 22:05 UTC a 7.5M earthquake, preceded by a strong foreshock, occurred in Venezuela. The impact on population is deemed high at this stage, with low visibility on the extent of the damage. Copernicus EMS Rapid Mapping is requested to provide damage assessment emergency mapping.

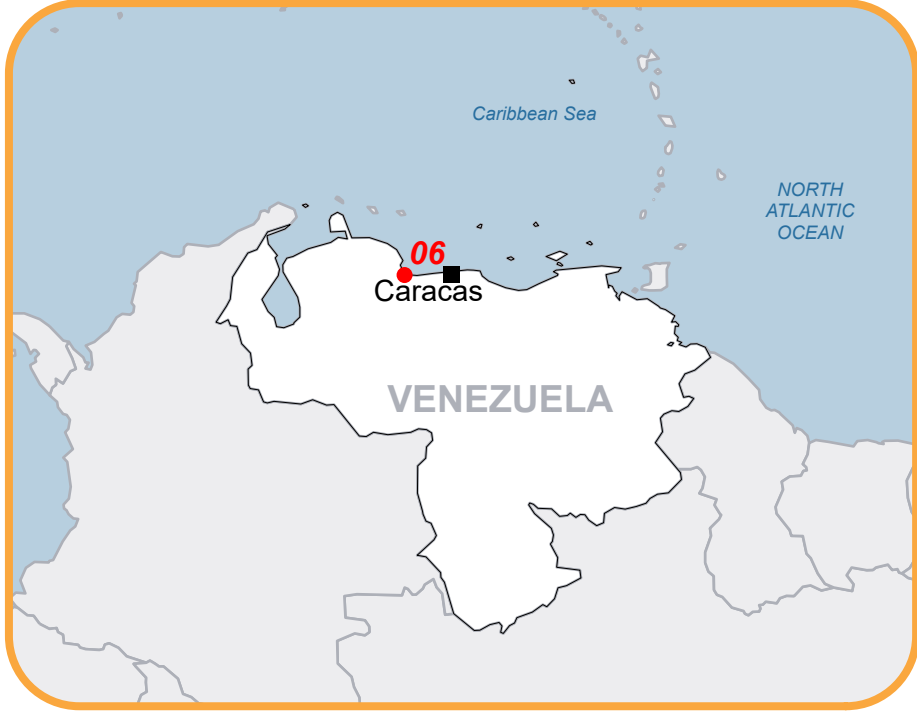
**Data sources and analysis:** Pre-event image: Legion © Vantor (2026), provided by European Space Imaging (acquired on 27/02/2026 at 16:34 UTC, resolution 0.3 m).  
Post-event image: Legion © Vantor (2026), provided by European Space Imaging (acquired on 25/06/2026 at 20:36 UTC, resolution 0.5 m).  
This image is used as background image.  
All images are provided under COPERNICUS by the European Union and ESA, all rights reserved.
