Event: Authorities in Brazil Rio Grande do Sul State declared a state of emergency on Thursday, 2 May 2024 after floods and mudslides caused by torrential rains left at least 30 people dead and 60 missing. Storm damage has affected nearly 150 municipalities, forcing over 15,000 people to flee from their homes. In some areas, the flood is so severe that entire communities have been completely cut off from road infrastructures and network. Copernicus EMS Rapid Mapping is requested to provide initial rough estimation, flood extent and damage assessment emergency mapping.

Map produced by e-GEOS released by e-GEOS on the 09/05/2024.

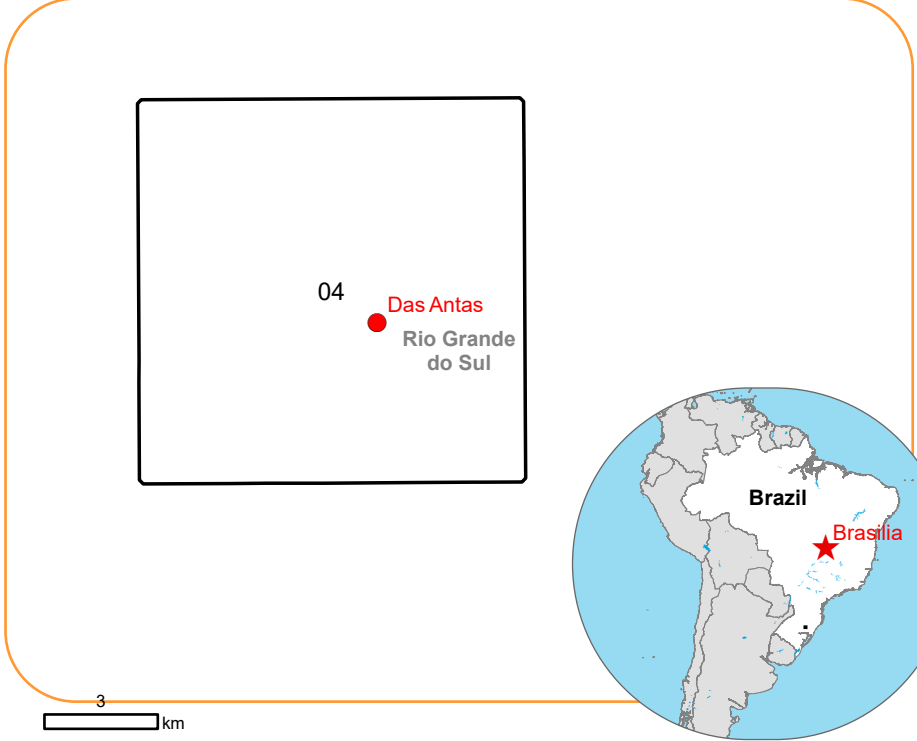
Landslide 318.7 ha
Flood trace 107.5 ha
Flooded area 71.2 ha

Potentially affected population ~ 150

Built-Up 294 No.
Road 22.1 km
Railway 3.1 km

The thematic layer has been derived from post-event satellite image using a semi-automatic approach.
