Situation as of 29/10/2023 23:08 UTC
Grading MONIT01 - Overview map 01

In the evening of 24 October 2023 local time, the Vanuatu archipelago was hit by the passage of a new tropical cyclone, named LOLA, with winds of up to 145 km/h. The cyclone has passed Solomon island, and will have an impact on parts of Vanuatu. The event is on-going and increasing over the next 48 hours with very heavy rainfall, strong wind and storm surge are forecast over the whole Vanuatu with damage expected to affect buildings and infrastructure. Copernicus EMS Rapid Mapping is requested to provide damage assessment emergency mapping.

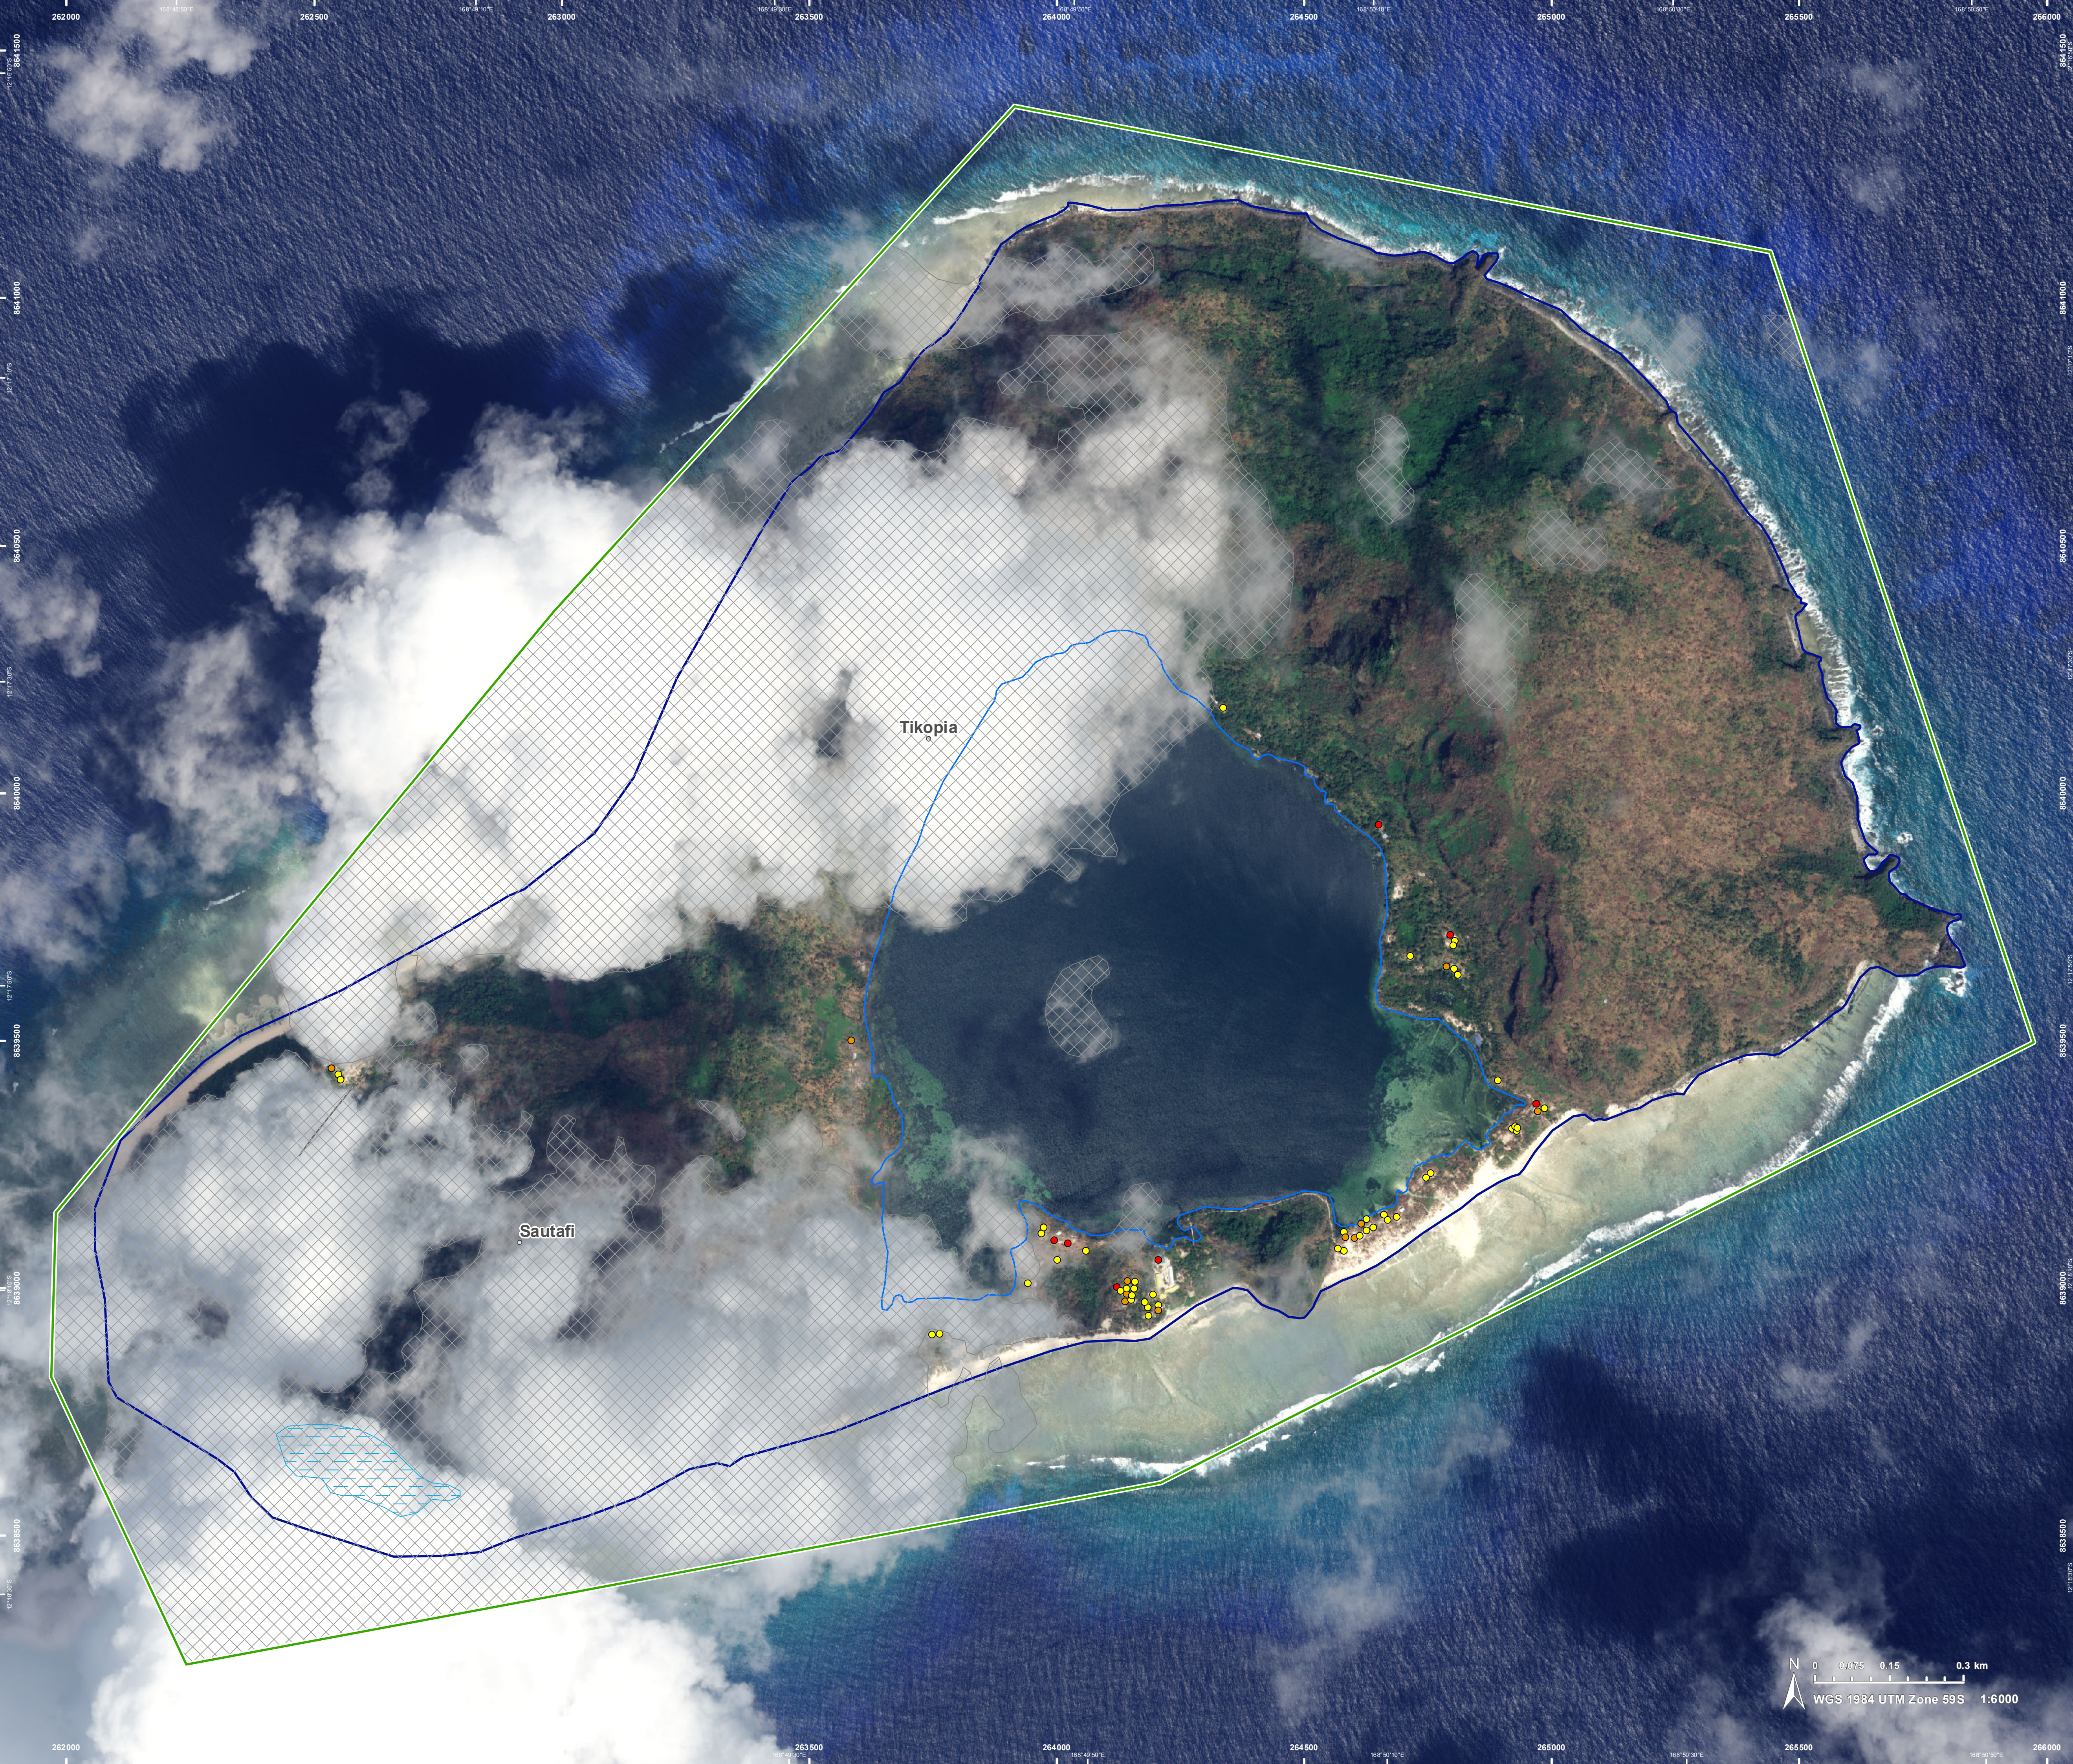
The thematic layer has been derived from post-event satellite image by means of visual interpretation.

Consequences within the AOI						
	Unit of measurement		Destroyed	Damaged	Possibly damage*	Total affected**
Estimated population	Number of inhabitants					NA
Built-up	Unclassified	No.	7	11	44	62
Transportation	Cart Track	km	0	0	0	0
Land use	Other	ha	0	0	0	0
Total in AOI						
* Presence of damage proxies and proximity with destroyed/damaged asset						
** Sum of all damage classes
