EMSR702 - AOI14
Storm in Vanuatu
AMBRYM

Situation as of 26/10/2023 22:57 UTC

Situation as of 26/10/2023 22:57 UTC
Grading - Detail map 02

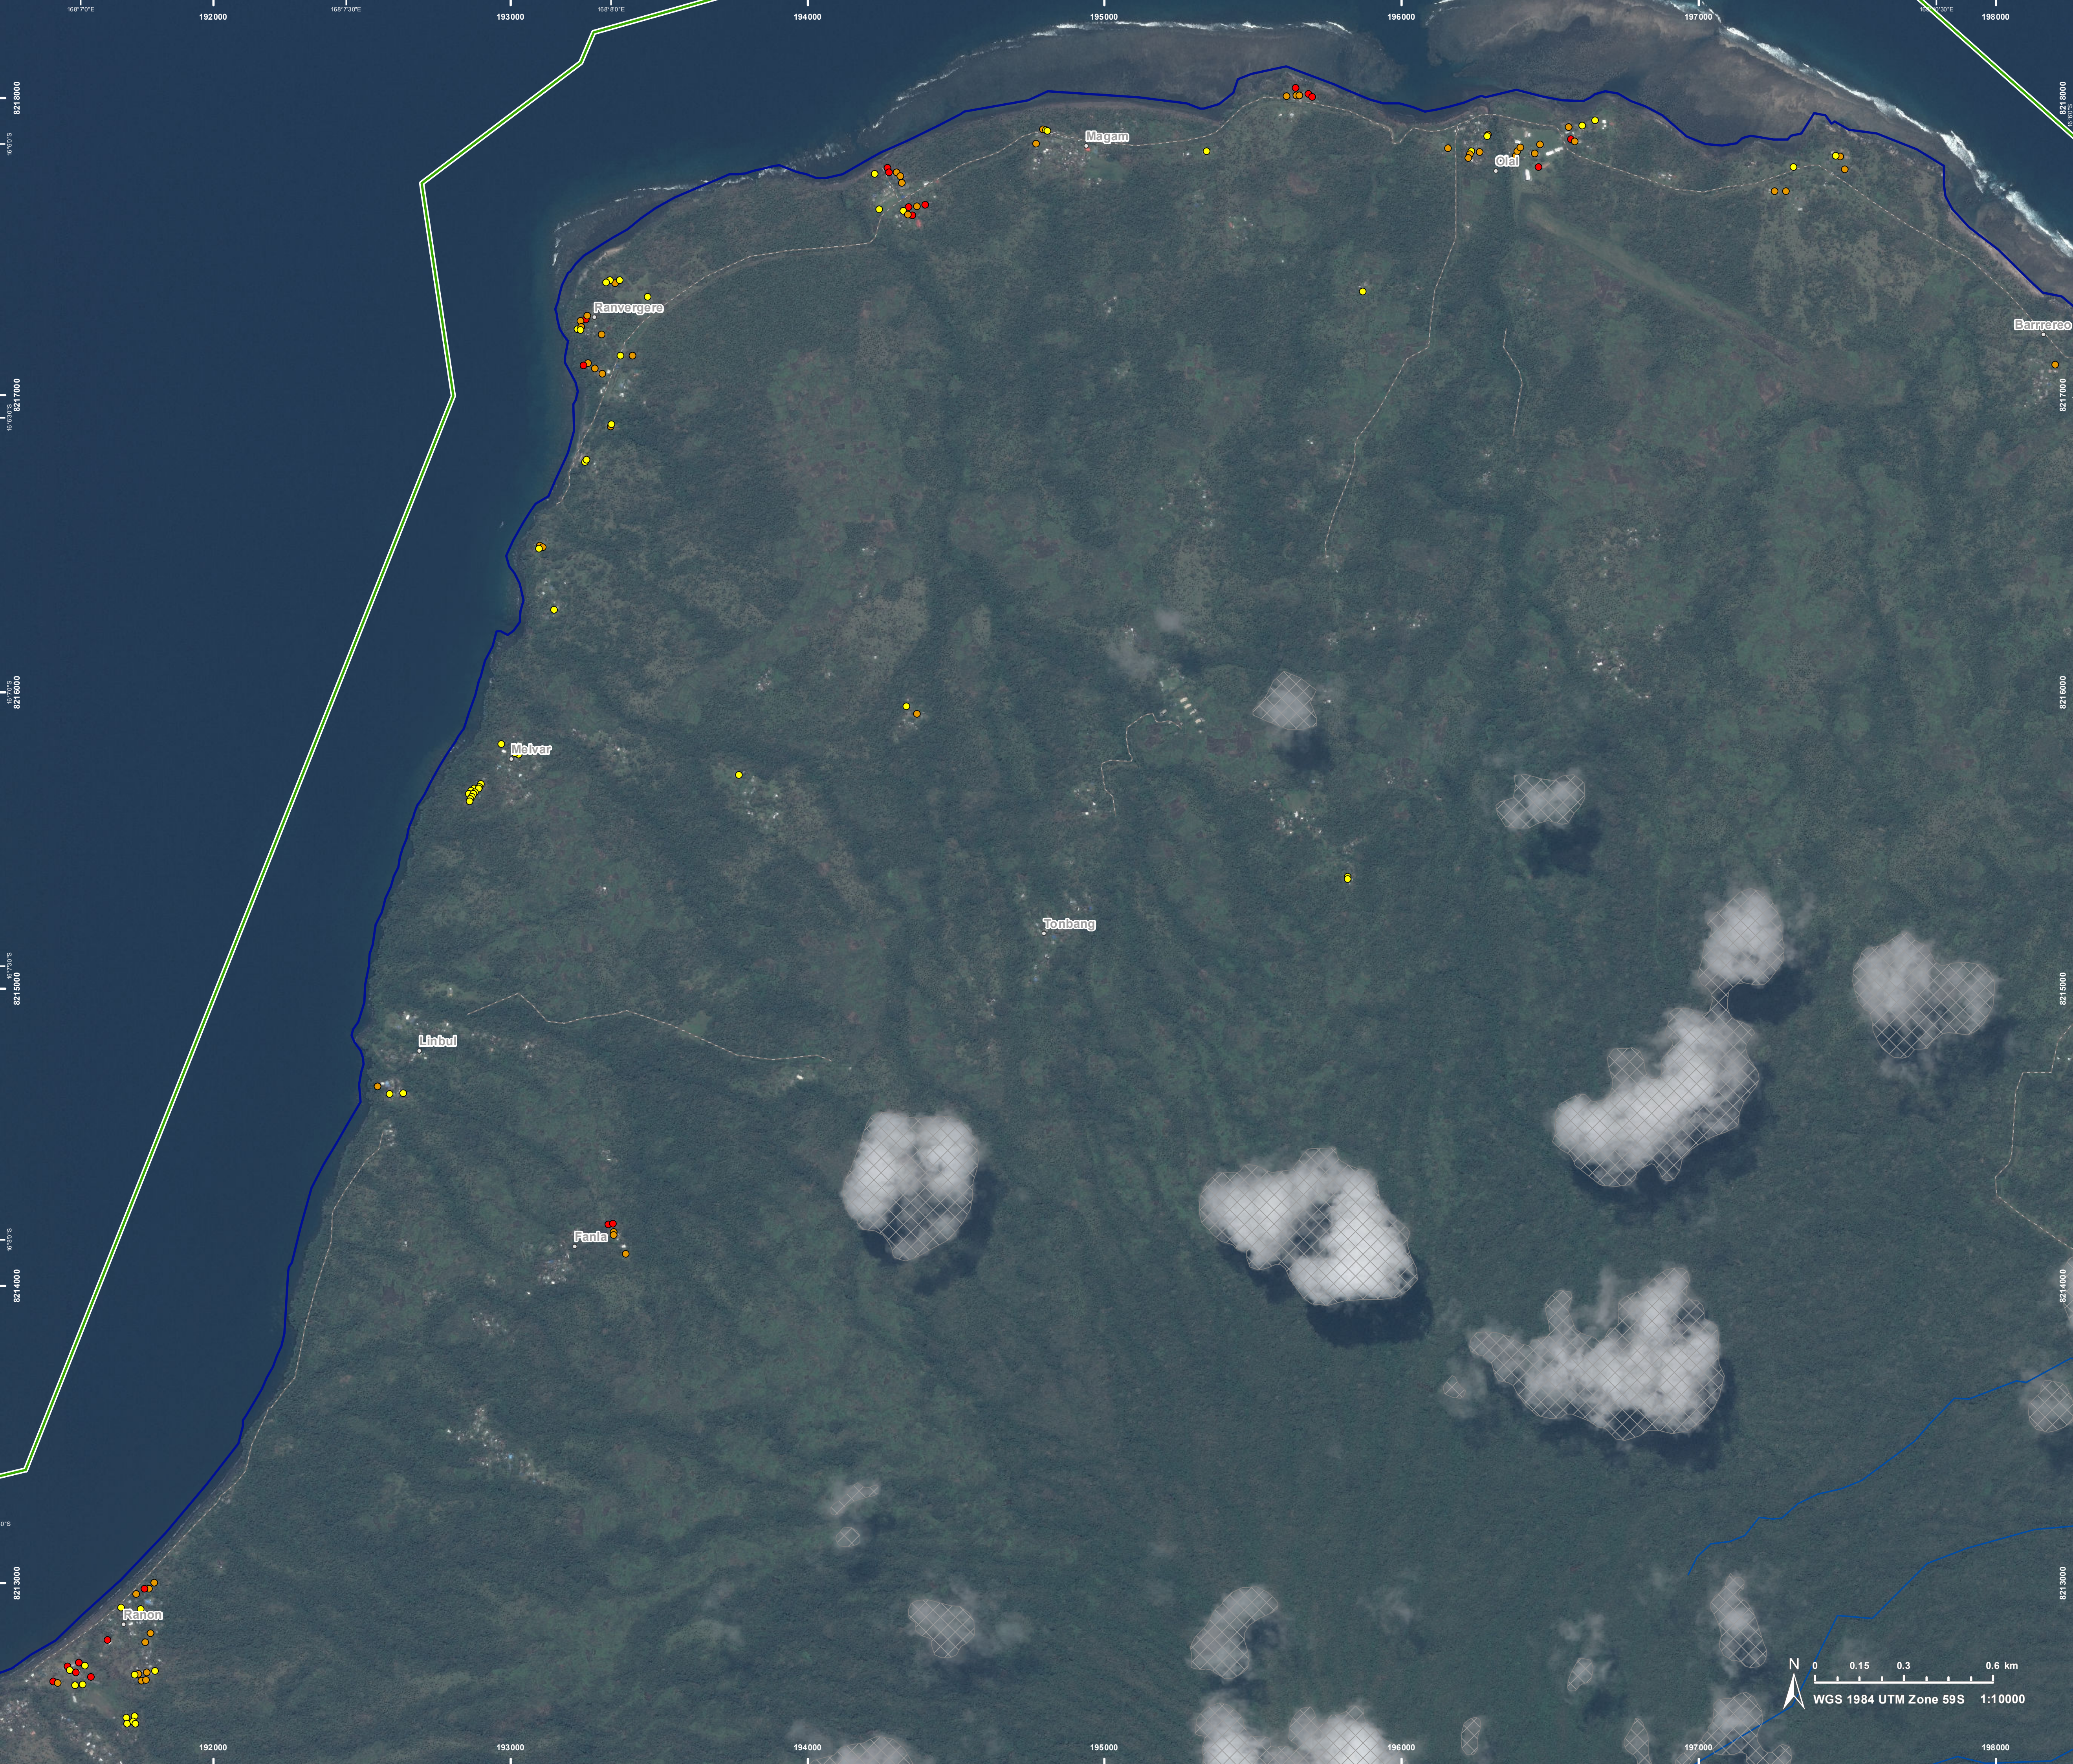
Affected Built-up and Transportations

7 No.

Built Up Grading

- Destroyed
- Damaged
- Possibly damaged

Transportation Grading

- Track, No visible damage
- Airfield runway, No visible damage
- Local road, No visible damage

The thematic layer has been derived from post-event satellite image by means of visual interpretation.

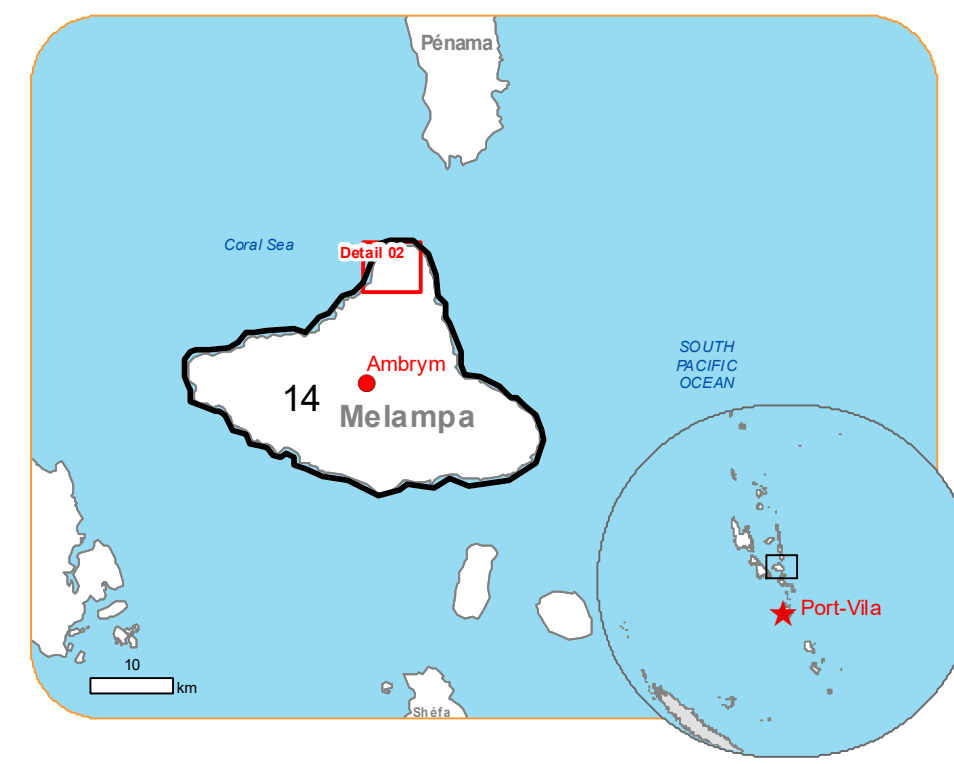
Affected Built-up and Transportations

Built-Up
133 No.
(90% of total affected)

Built Up Grading

- Destroyed
- Damaged
- Possibly damaged

- Track, No visible damage

The thematic layer has been derived from post-event satellite image by means of visual interpretation.

Consequences within the AOI							
	Unit of measurement		Destroyed	Damaged	Possibly damage*	Total affected**	Total in AOI
Estimated population	Number of inhabitants					NA	~ 8,800
Built-up	Residential Buildings	No.	3	18	10	31	439
	Wholesale and retail trade buildings	No.	0	1	0	1	10
	School, university and research buildings	No.	0	0	0	0	5
	Hospital or institutional care buildings	No.	0	0	0	0	1
	Buildings used as places of worship and for religious activities	No.	1	0	0	1	4
	Other buildings not elsewhere classified	No.	0	0	0	0	1
	Unclassified	No.	17	37	60	114	3,894
Transportation	Airfield runways	km	0	0	0	0	1.8
	Local Road	km	0	0	0	0	2.3
	Cart Track	km	0	0	0	0	77.2
Facilities	Sport and recreation constructions	ha	0	0	0	0	0.01
Land use	Heterogeneous agricultural areas	ha	0	0	0	0	3.5
	Forests	ha	0	0	0	0	55,921.7
	Shrub and/or herbaceous vegetation association	ha	0	0	0	0	1,565.1
	Open spaces with little or no vegetation	ha	0	0	0	0	2,406.8
