Situation as of 26/10/2023 22:57 UTC
Grading - Overview map 01

EMSR702 - AO114

Storm in Vanuatu

AMBRYM

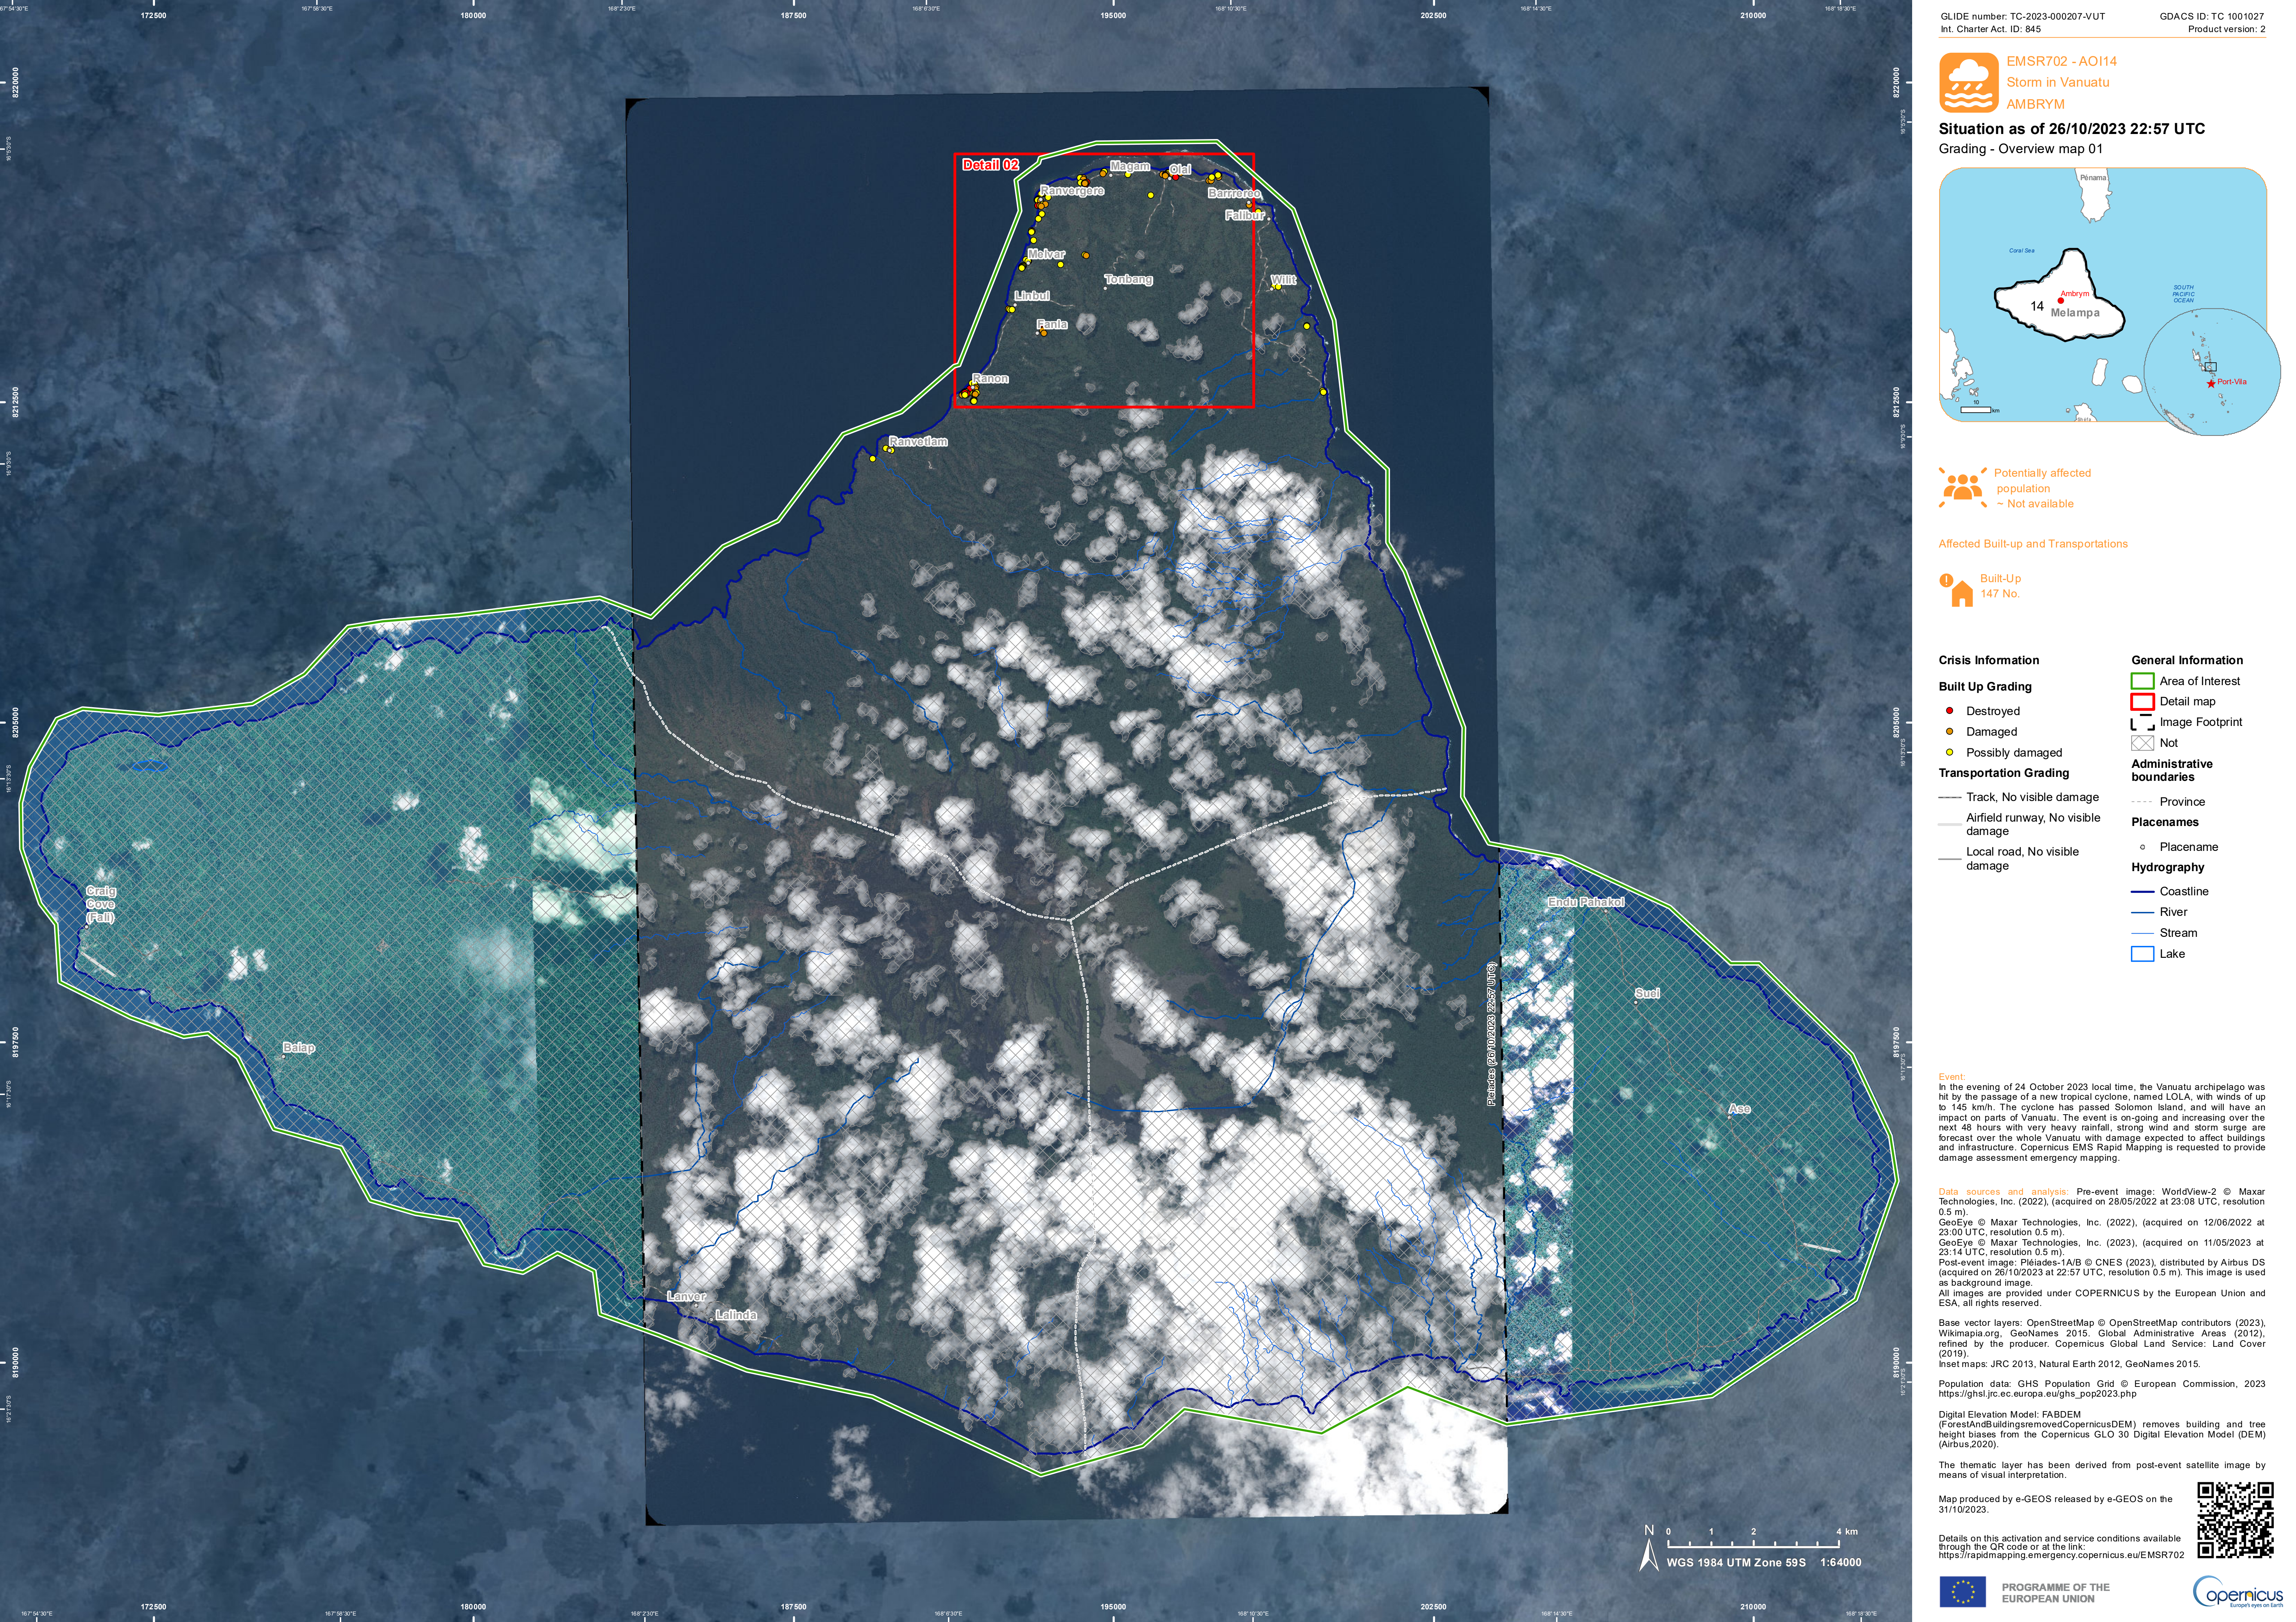
The thematic layer has been derived from post-event satellite image by means of visual interpretation.

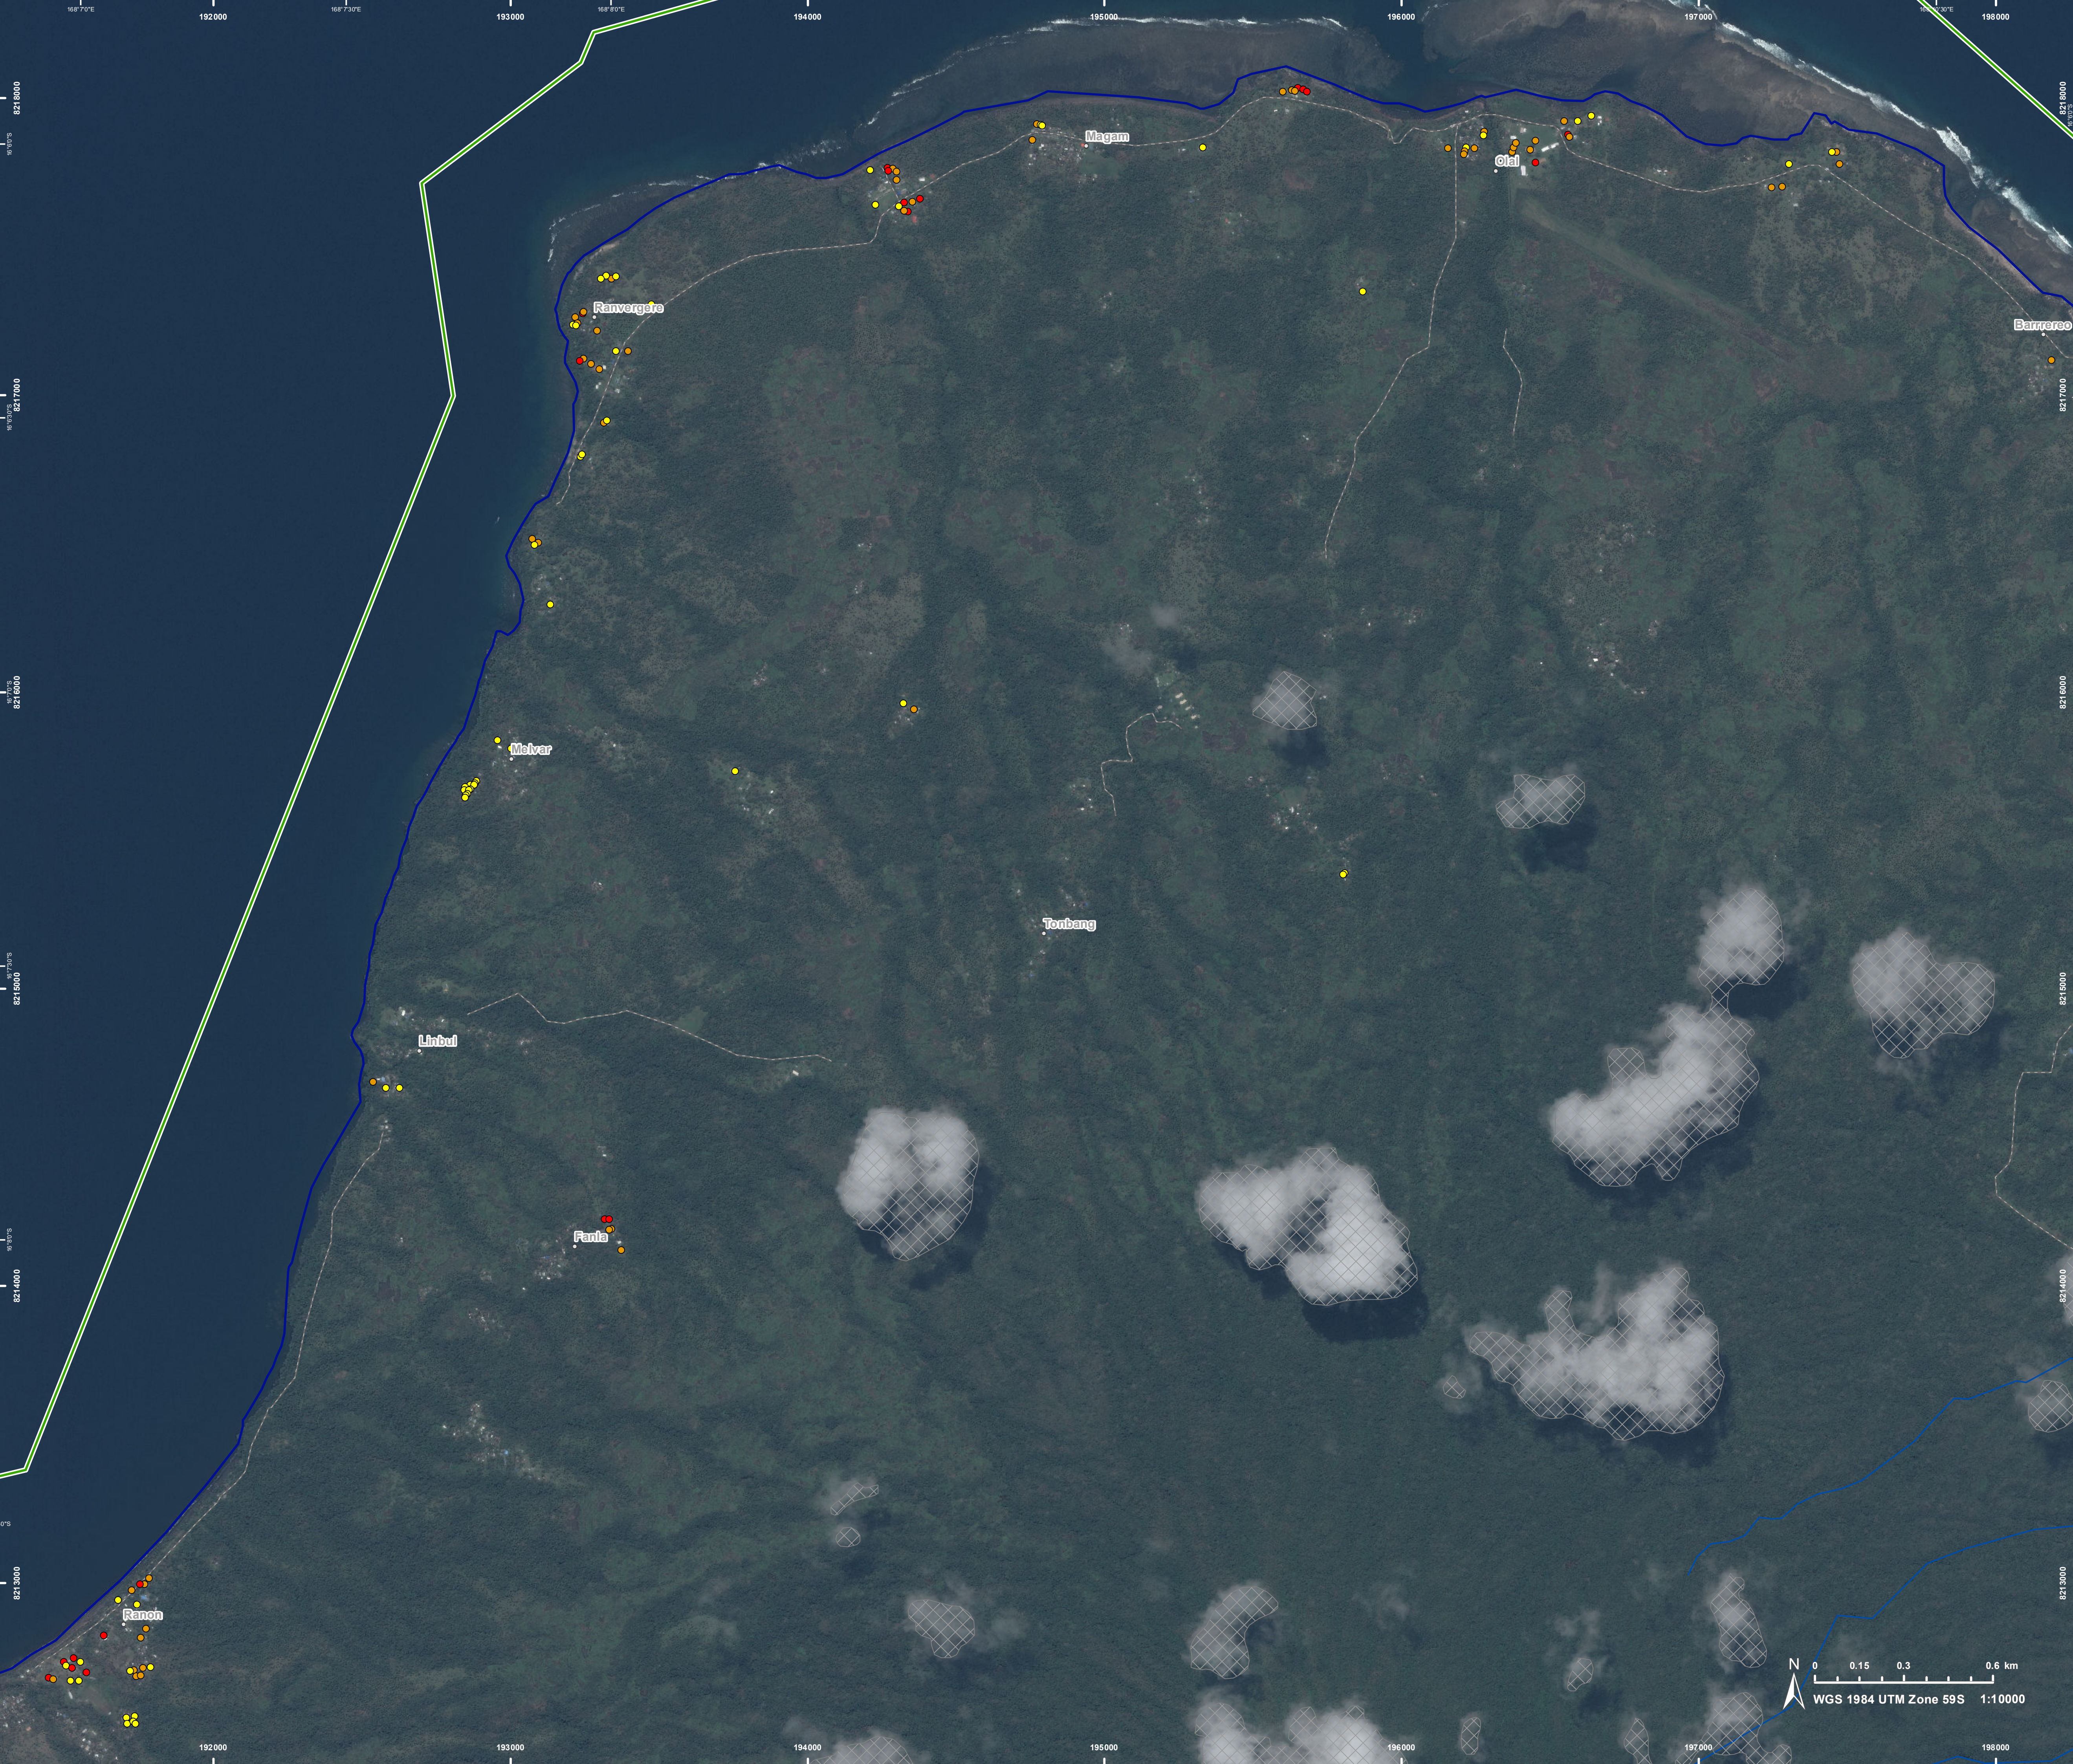
Situation as of 26/10/2023 22:57 UTC
Grading - Detail map 02

133 No.

(90% of total affected)

The thematic layer has been derived from post-event satellite image by means of visual interpretation.
