EMSR851 - AOI04
Flood in Sri Lanka
HAKGALA

Situation as of 02/12/2025 05:25 UTC
Grading - Overview map 01

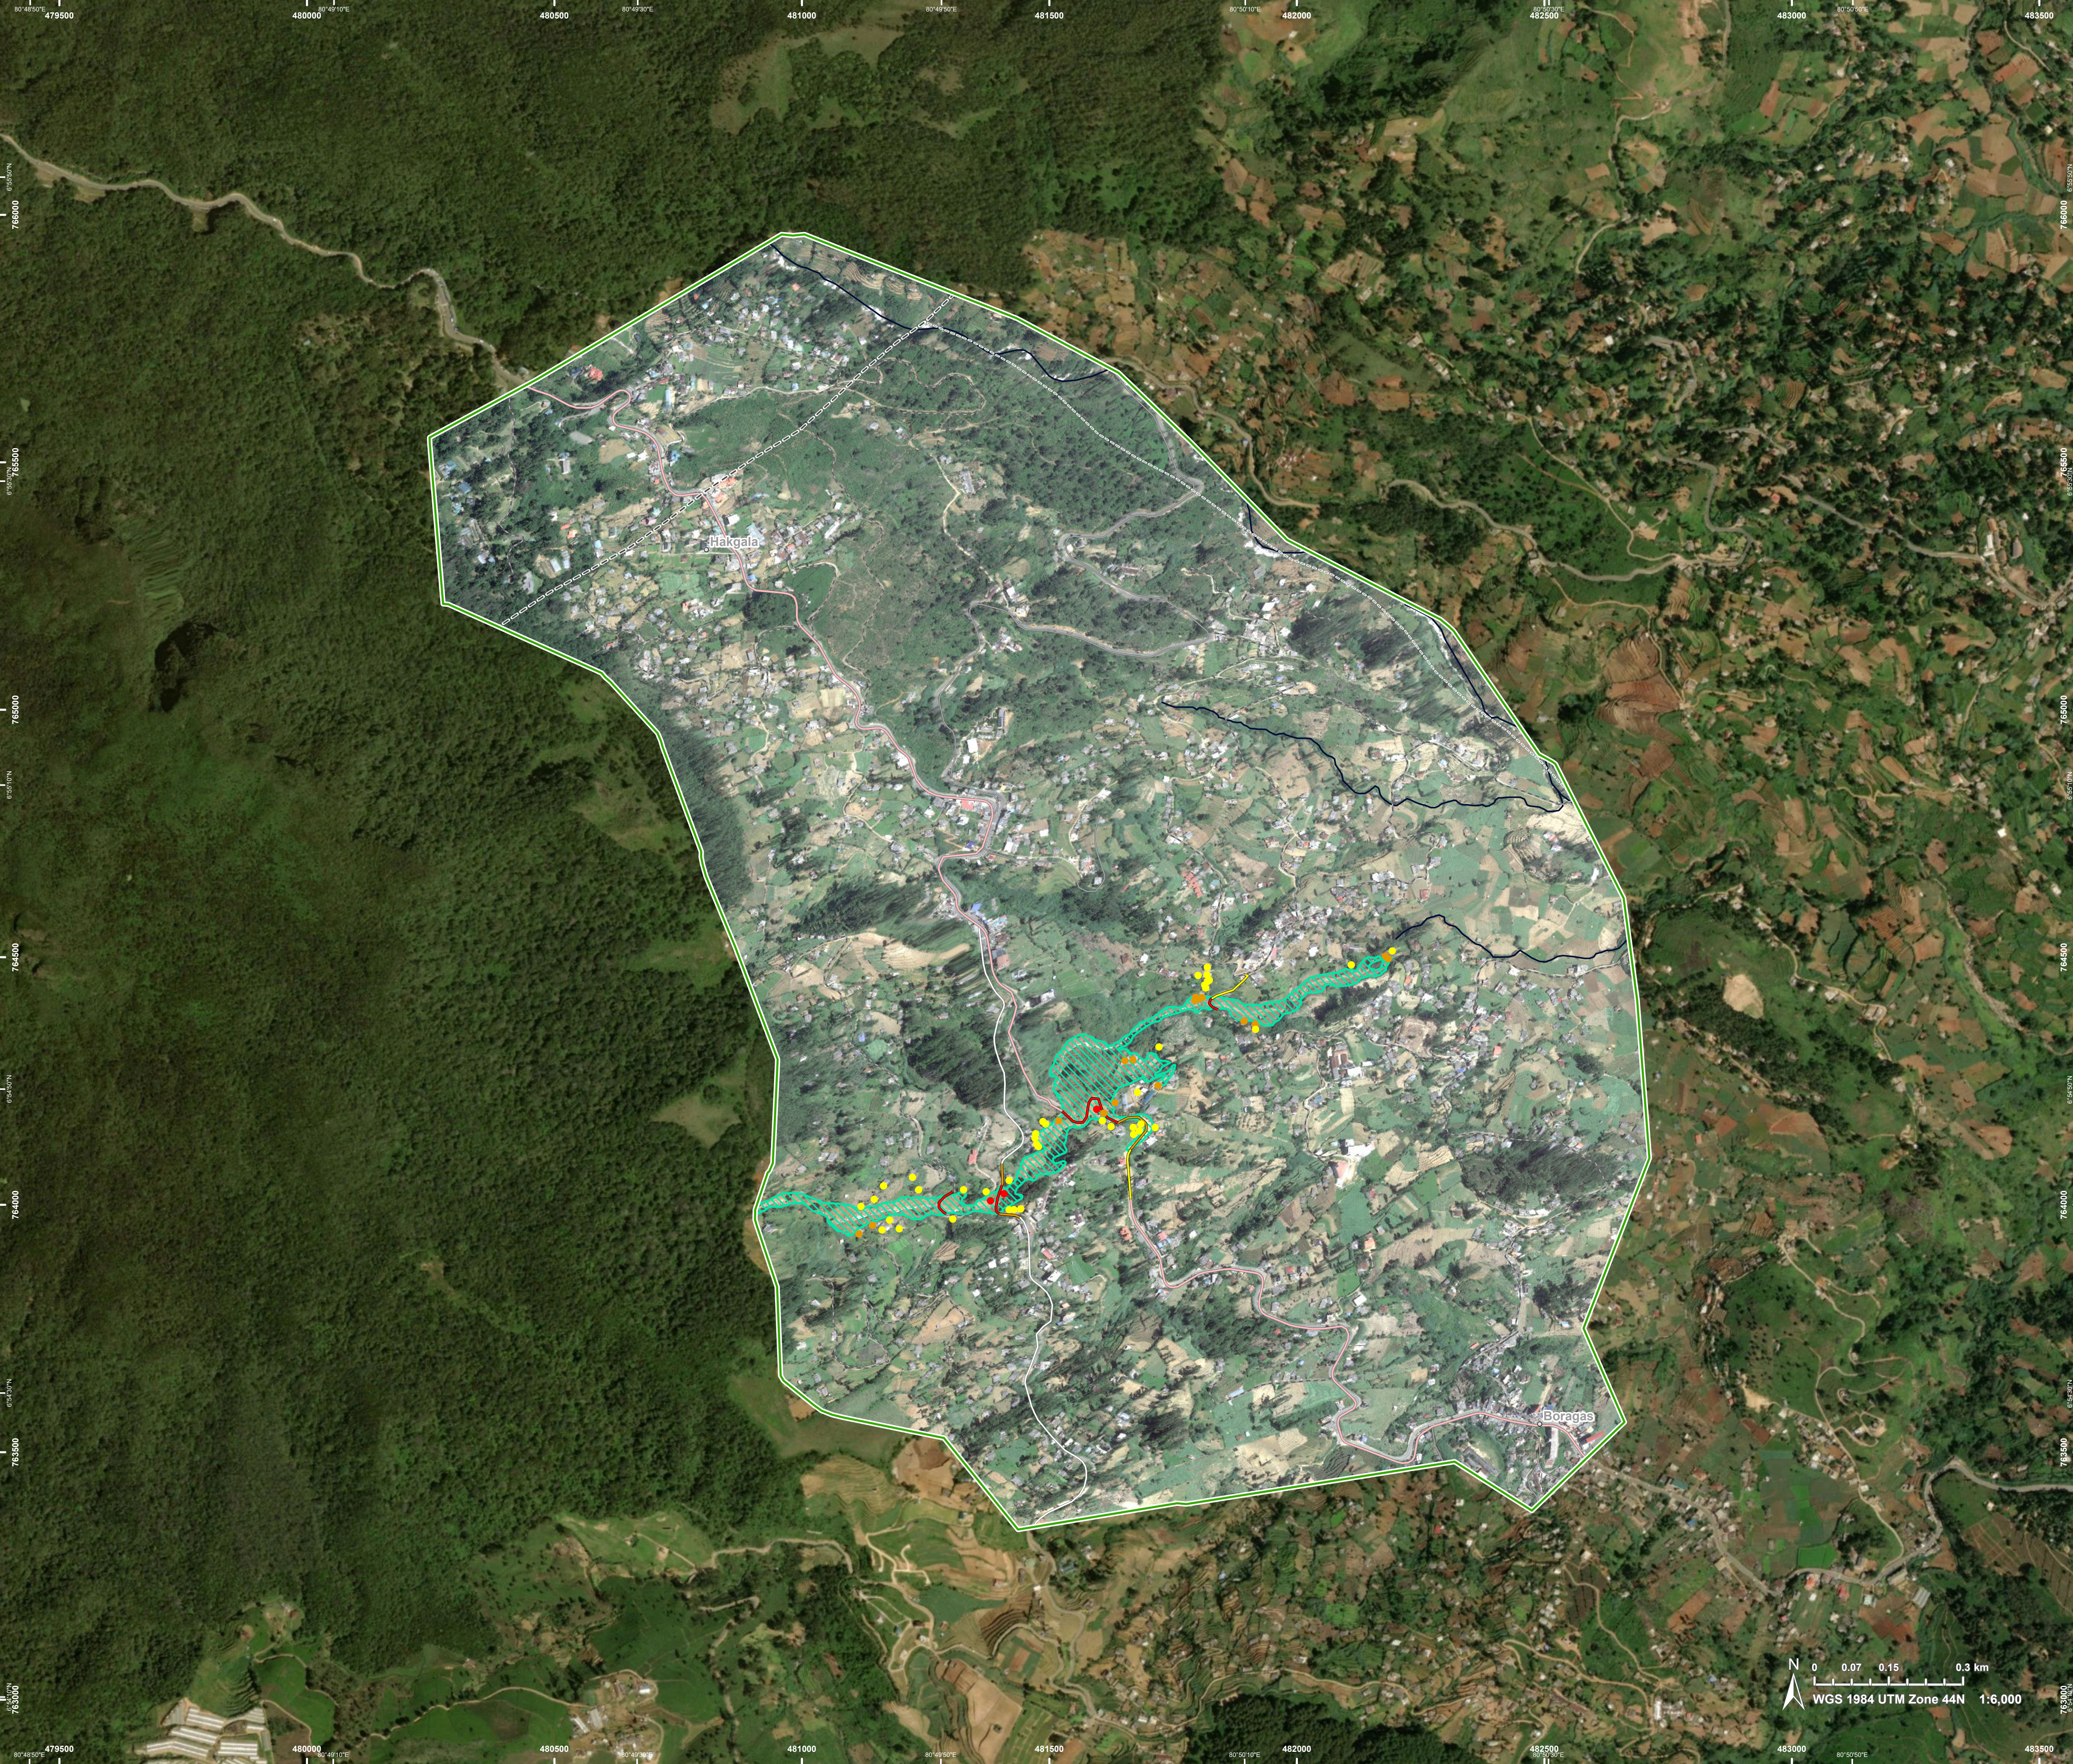
Flood trace
6.5 ha

Potentially affected population
~ 100

Affected Built-up and Transportations

Built-Up
59 No.

Road
0.8 km

Event: On the 27 November 2025, Tropical Cyclone DITWAH-25 formed over Sri Lanka. The event has caused heavy damage across the country, with floods, landslides and mudslides reported. Copernicus EMS Rapid Mapping is requested to provide flood extent and damage assessment emergency mapping.

The thematic layer has been derived from post-event satellite image by means of visual interpretation.

LATEST IMPACT	
			Unit of measurement	EO-based observation*
Crisis information	Flood trace		ha	6.5
	Maximum of all extents**		ha	6.5

Estimated population		Inhabitants	No.	Destroyed	Damaged	Possibly damaged***	Total affected****	Total in AOI
Assets		Built-up	No.	3	16	40	~ 100	~ 6,200
		Residential Buildings	No.	0	0	0	59	1,389
		Other non-residential buildings	No.	0	0	0	0	1
		Transportation	km	0.2	0.1	0.1	0.4	4.2
		Highways	km	0.1	0.1	0	0.2	1.4
		Secondary Road	km	0	0	0	0	2.8
		Local Road	km	0	0	0	0	13.9
		Cart Track	km	0.1	0	0.1	0.2	
		Facilities	ha	0	0	0	0	10.1
		Sport and recreation constructions	ha	0	0	0	0	4.8
		Long-distance pipelines, communication and electricity lines	km	0	0	0	0	
		Land use	ha				6.5	397.5
		Heterogeneous agricultural areas	ha				0	5.1
		Forests	ha
